MASTER PLAN

AGRICULTURAL CENTER BUILDING ESSEX COUNTY CCE OFFICES

WESTPORT, NEW YORK

DECEMBER 2005

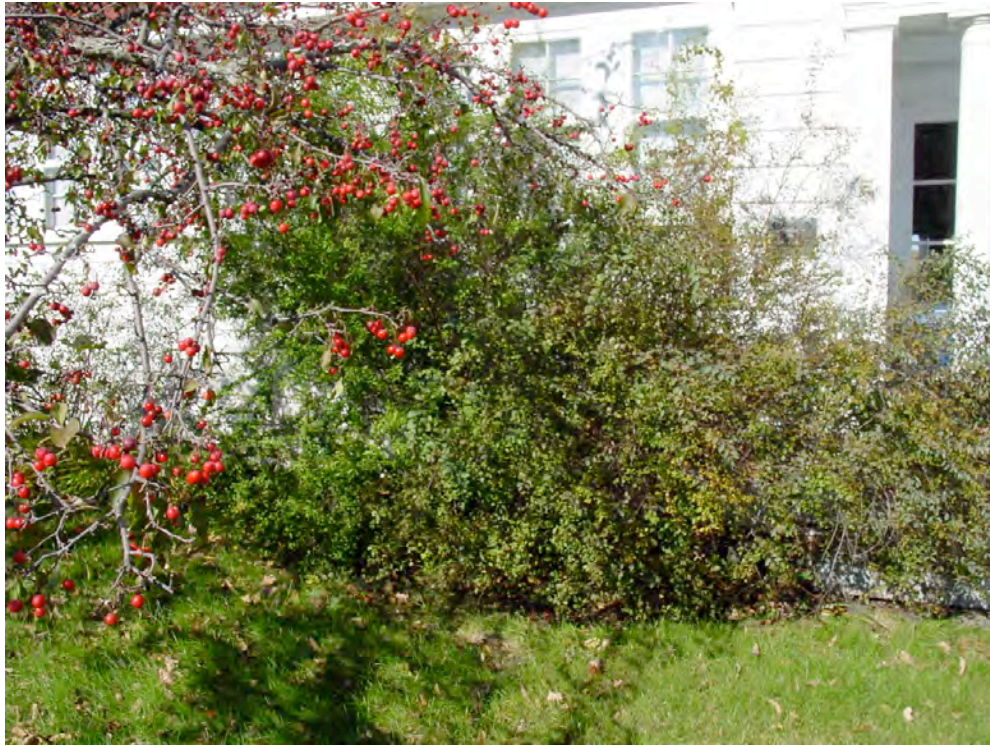
EC-1a: South Façade, west portion.

Recommendation: Trim back shrubs and vegetation within three feet of the facades.

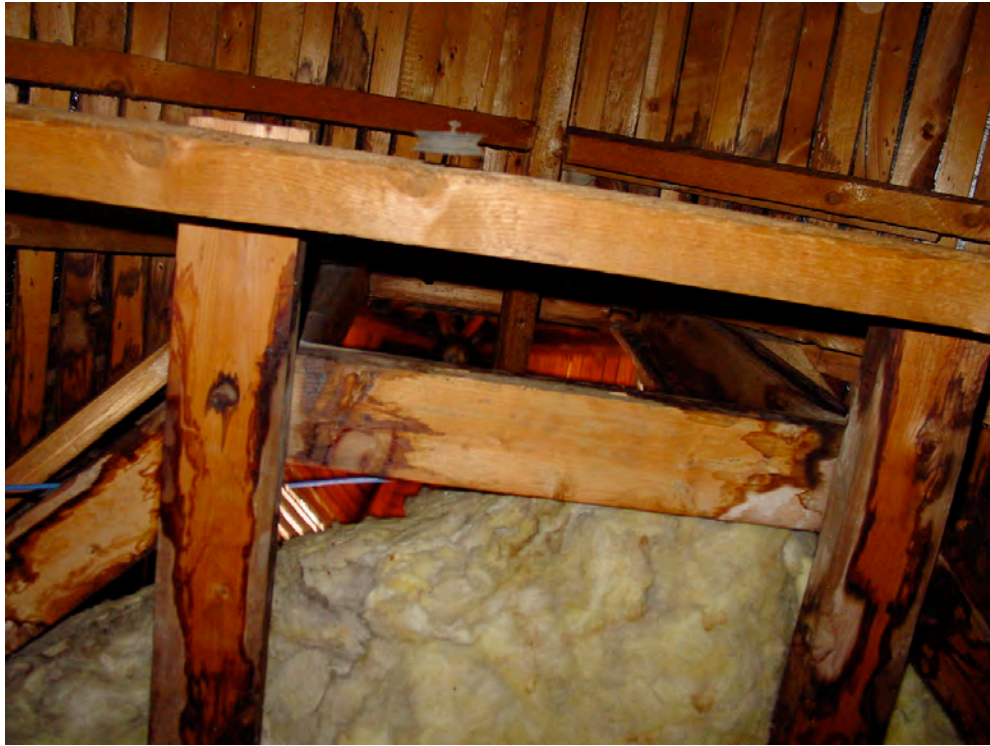
EC 2. The cupola and some of the roof flashings leak although the asphalt shingles are a recent replacement.

EC-2a: Looking up into cupola from roof void. Note water stains.

Recommendations: Install top flanges on the cupola louvers to arrest rain intake. Otherwise, install a metal drain pan in the main attic beneath the cupola with a drain

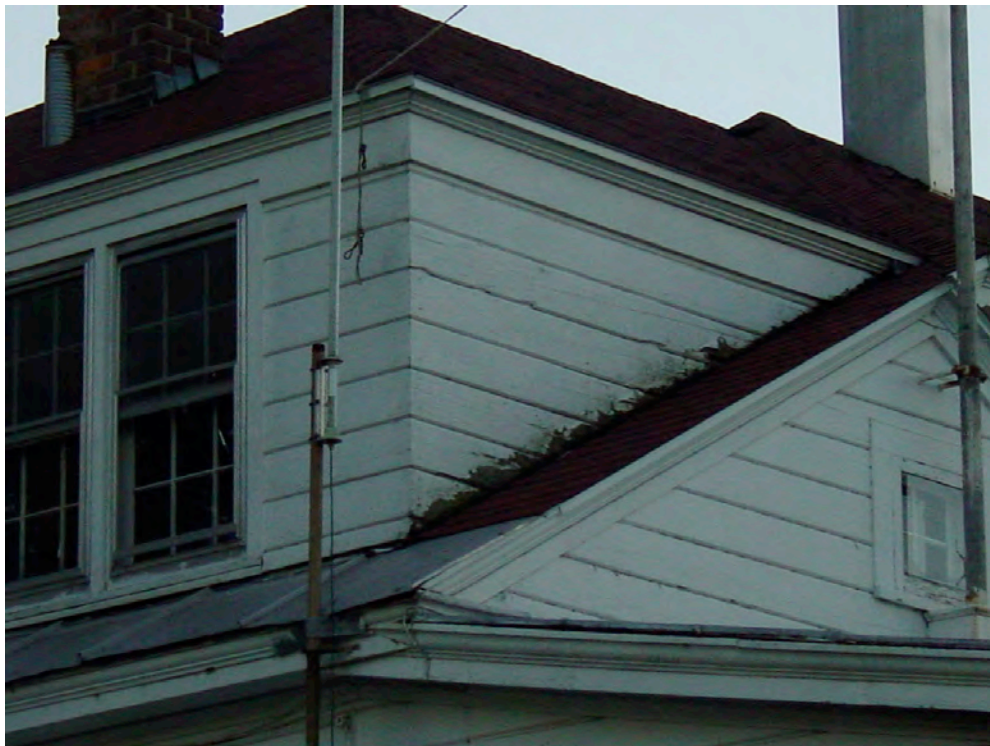
EC-2b: Dormer flashing which leaks, east end of main roof.

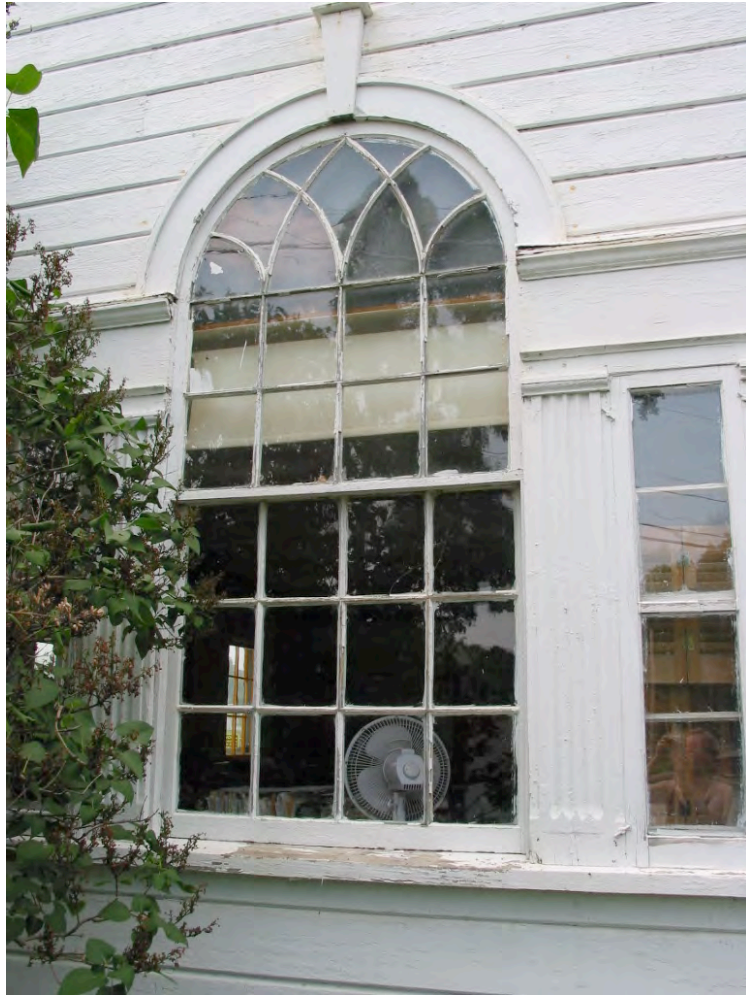
EC 3. The roof and porch cornices, cornice returns, facade trim, windows and siding all show the start of wood deterioration beyond the loss of paint coatings.

EC-3a: Palladian window in need of repair and maintenance. Note missing plinth on pilaster.

Recommendations: Repair in kind by replacing only rotted elements and rotted portions of elements so as to retain the maximum amount of historic material possible. Match missing moldings.

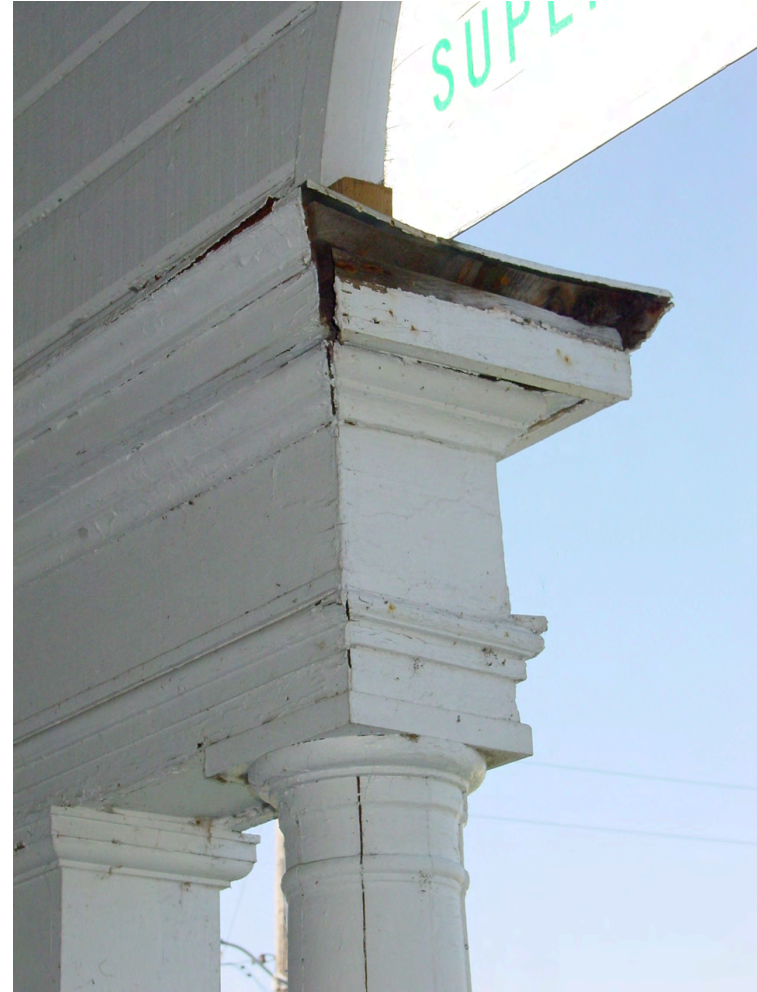
EC-3b: Detail of entablature at north portico missing crown and portion of tenia molding.

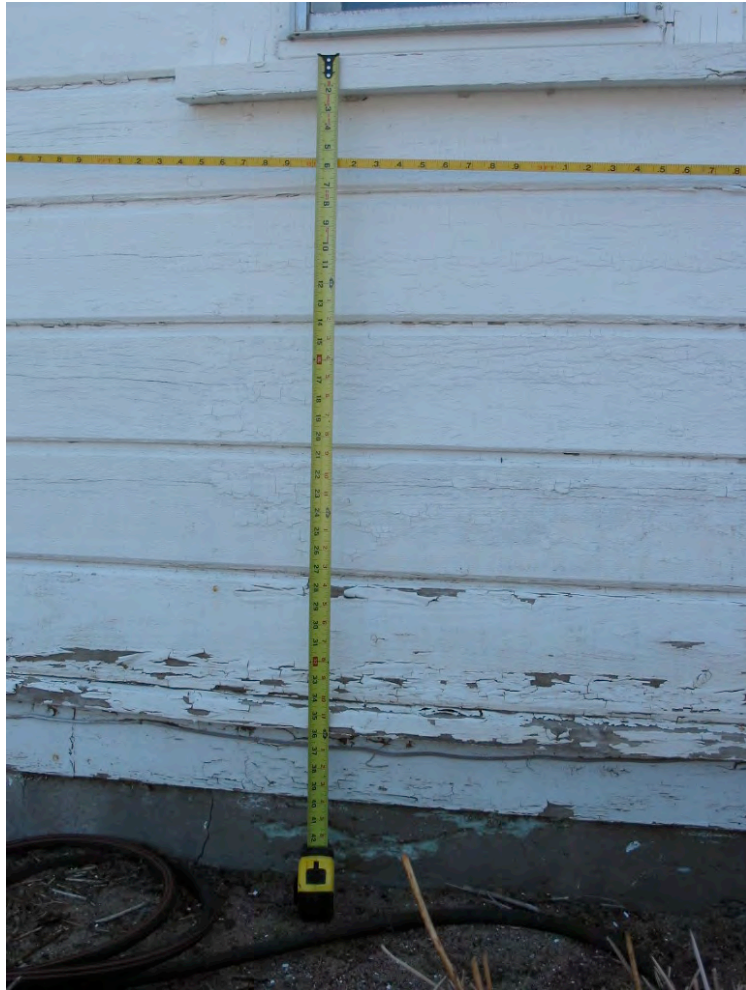
EC-3c: Detail of water table with loss of paint.

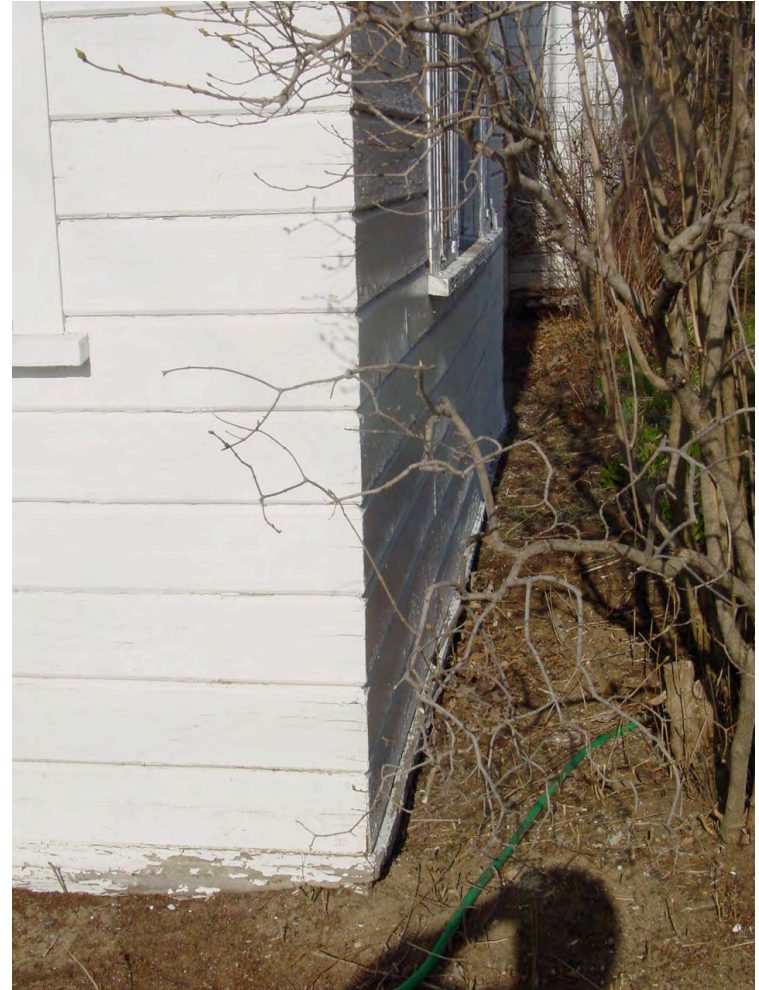
EC 4. Ground level is up around the wooden water tables, particularly at the southwest corner of the building coming toward the main front door. Also, the basement floods periodically during spring thaw. The concrete stoops or lowest steps are either broken or are out of place.

EC-4a: Detail of southwest corner with ground again wooden façade.

Recommendation: Re-grade so that the ground is at least 6 inches beneath the water table and it slopes away from the foundation walls and piers. Whether or not to install eaves troughs is a topic to settle. Eaves troughs can be put up which will withstand winter ice but they still require a level of maintenance, which is not to be taken for granted. In short, it is recommended that half-round gutters be installed, with downspouts, along the south main eaves on either side of the center door and along the north main eaves, west of the center door. Repair the concrete stoops with a polymer modified concrete patching mix, if possible, and reset for elevation. Otherwise cast new ones.

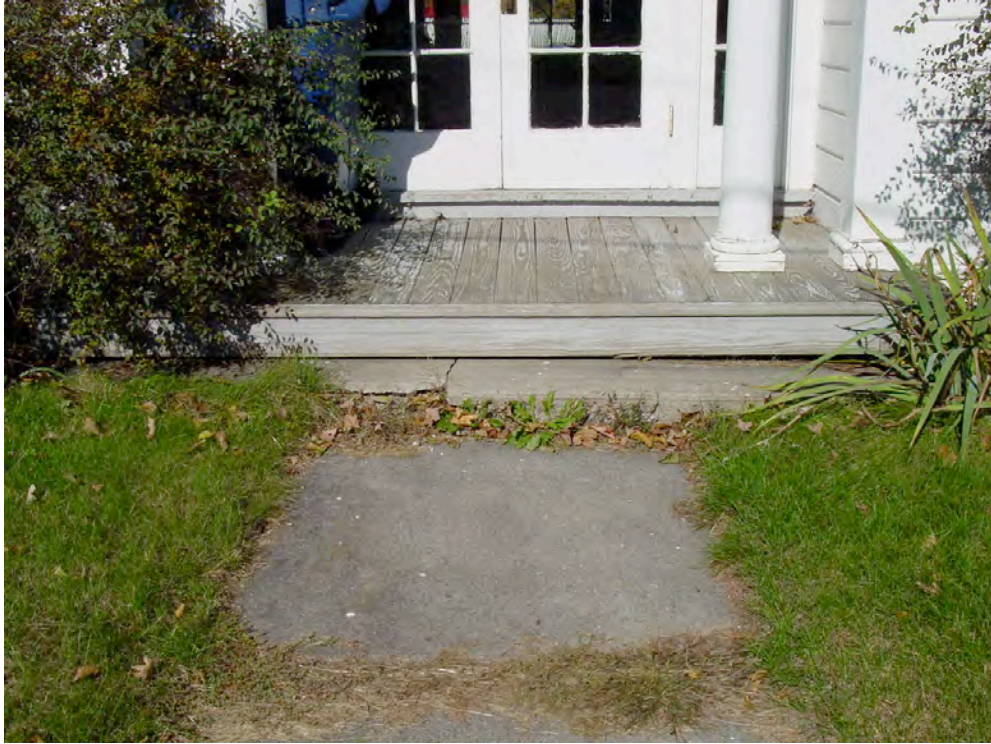
EC-4b: Broken concrete stoop at south portico.

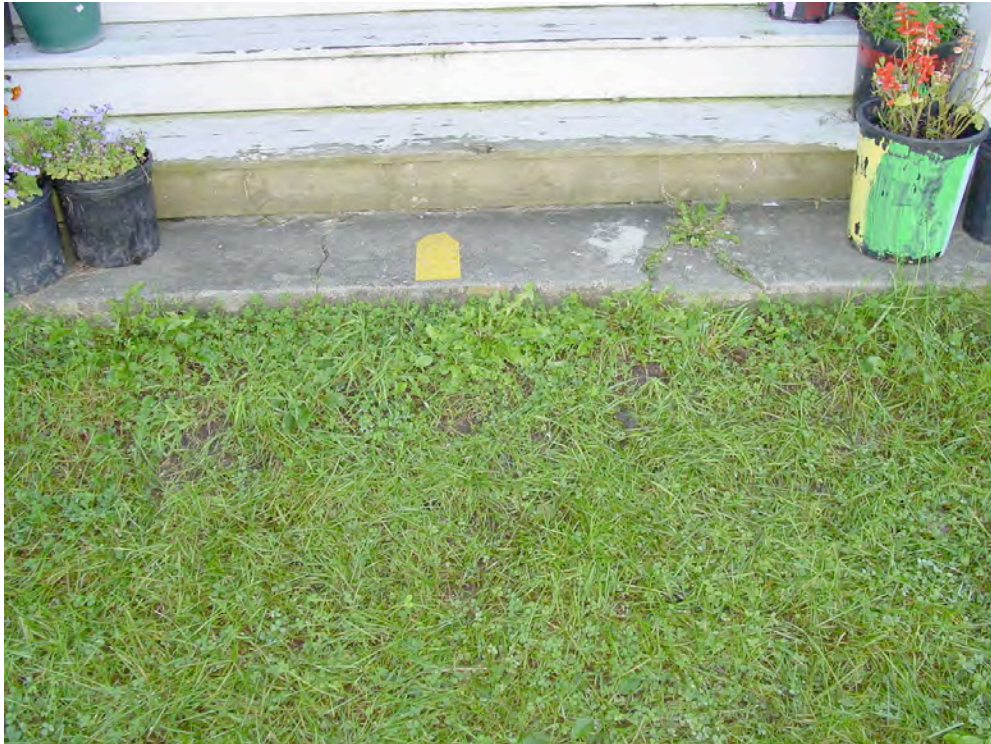
EC-4c: Broken concrete stoop at north portico.

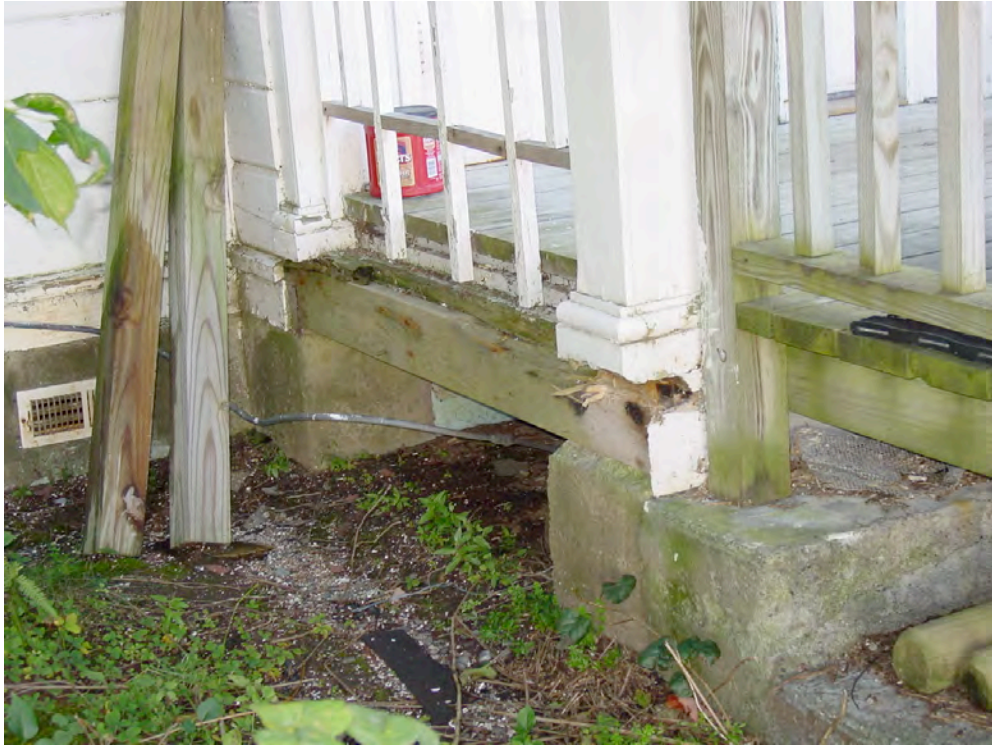
EC 5. The decks of all the open porches are shabby looking and they have been replaced with pressure treated material except the north portico on the north-south axis. The north portico deck has been spliced at the five foot line and the lowest concrete step at each of the north and south center porticoes is fractured and in need of repair. The square and round columns are also deteriorated at the center entrances, the north colonnade being particularly cracked. All wooden steps are also becoming deteriorated, especially the set at the east end of the long north porch.

EC-5a: Porch edge rotted away at northwest entry.

Recommendation: Replace deteriorated decking in kind, painting each tongue and groove piece first and securing with non-ferrous fasteners. Prepare, prime and paint with a non-skid additive. Repair the columns in kind. Vent the shafts and paint.

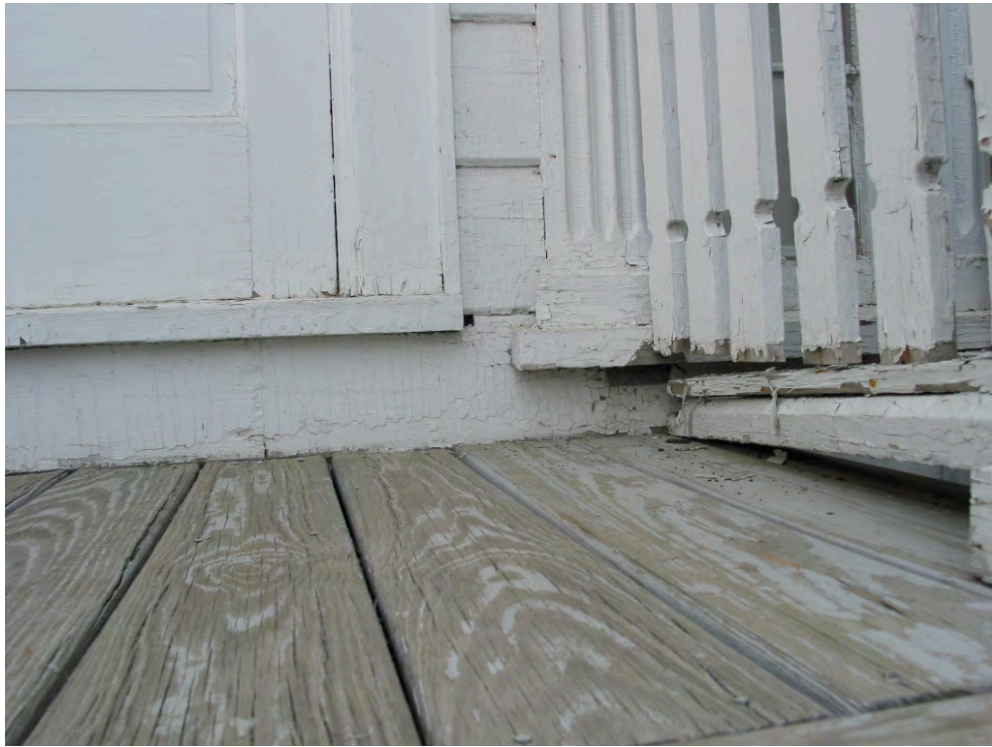
EC-5b: Railing deterioration at southeast entrance landing.

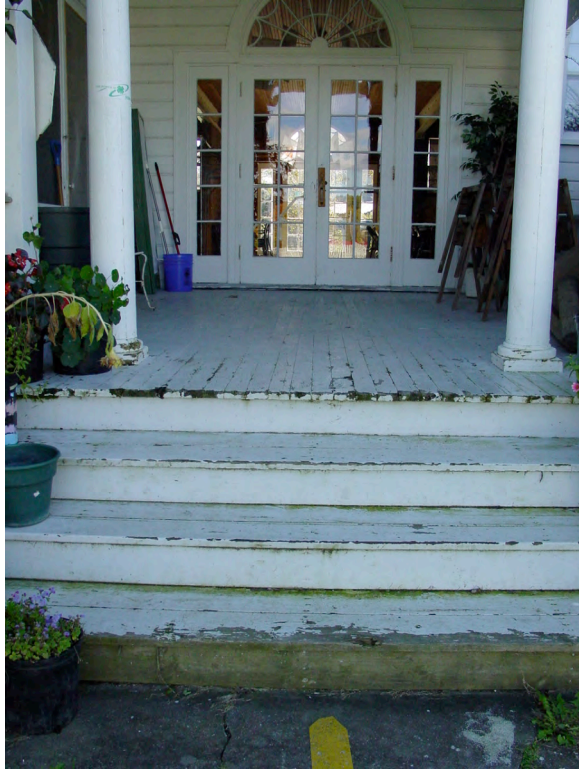
EC-5c: Decking starting to weather at north portico

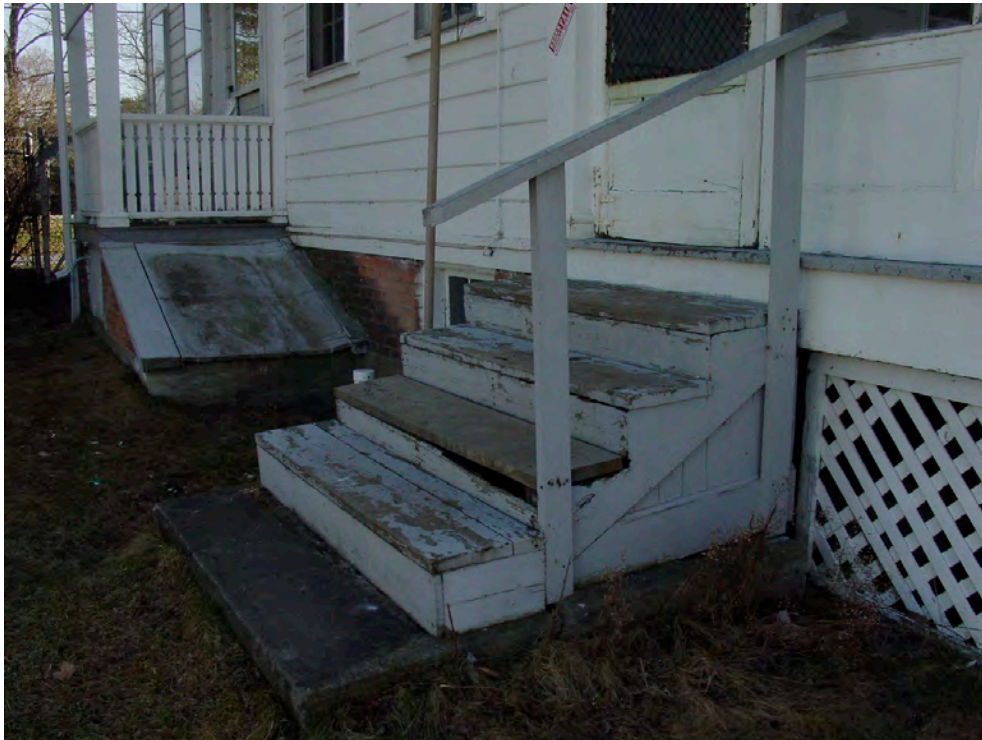
EC-5d: Deterioration at east steps to north porch.

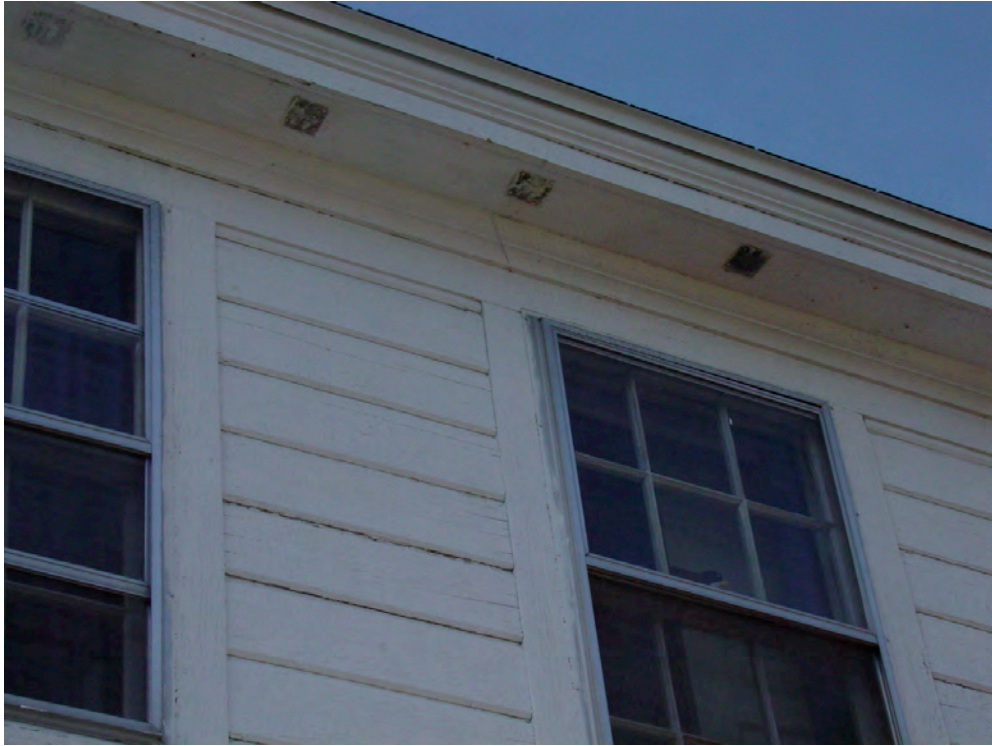
EC 6. The roof cornice intake vents are rusted and are partially painted shut. It is suspected that they are also blocked by the blown-in insulation in the main attic.

EC-6: Rusty vents in planceer piece (soffit).

Recommendation: Replace with new, metal vents with micro-louvers. If total area for intakes is still less than free area of cupola louvers, increase number of or redesign soffit vents to equate. Also, install vent chutes to allow air circulation if necessary.

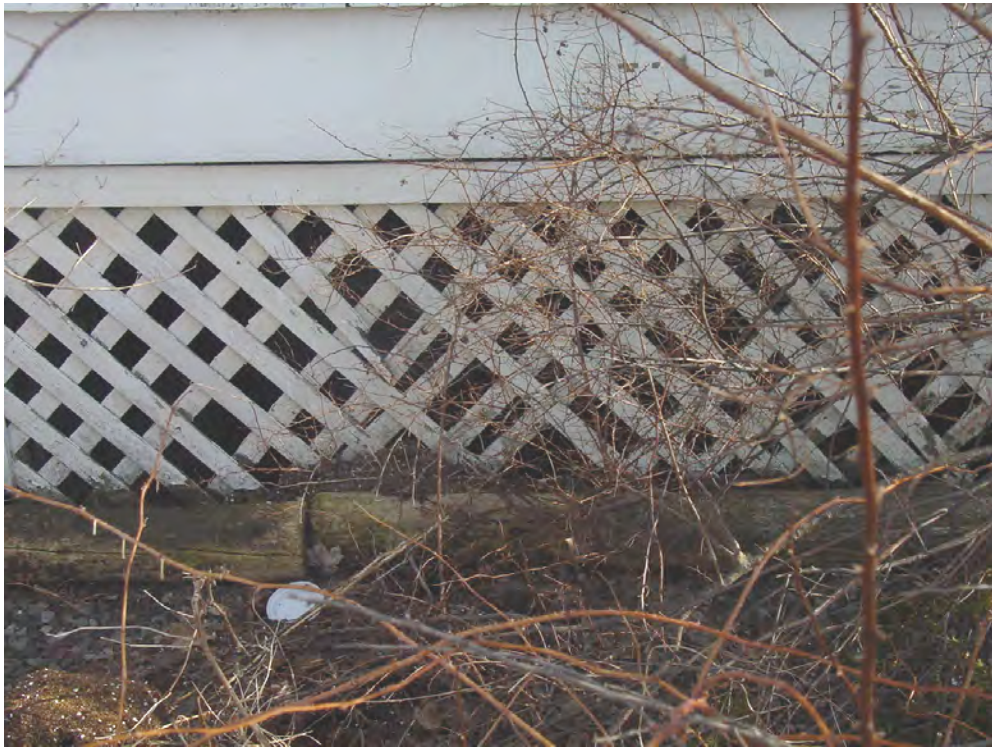
EC 7. Painted wooden trellis along the north (back) porch perimeter is damaged and deteriorated.

EC-7: Deteriorated trellis.

Recommendation: Repair in kind, prepare and paint.

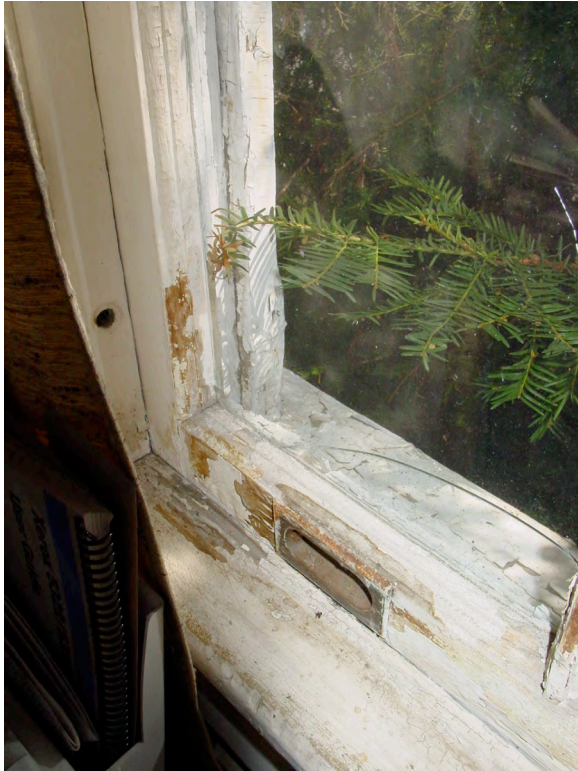
Windows and trim are deteriorated in specific areas.

IC-2a: Detail of paint deterioration on window components.

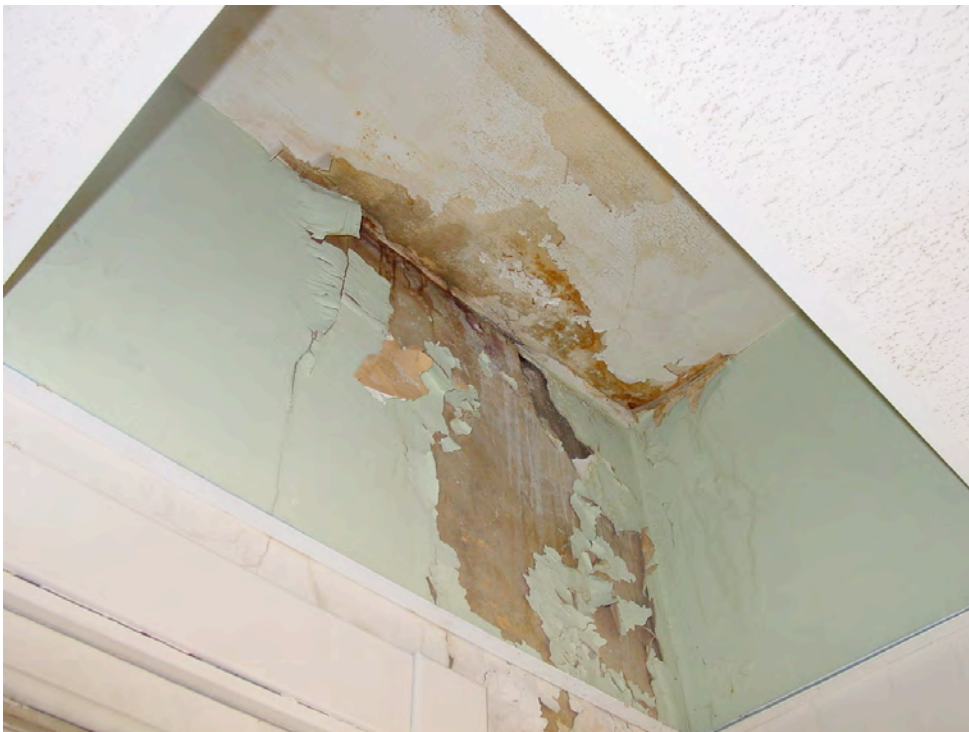
IC-2b: Water damage to plaster and paint finishes.

Recommendations: Trace the leakage during a heavy rainstorm and reseal the relevant roof and wall intersections by caulking the flashings at dormer sidewalls.

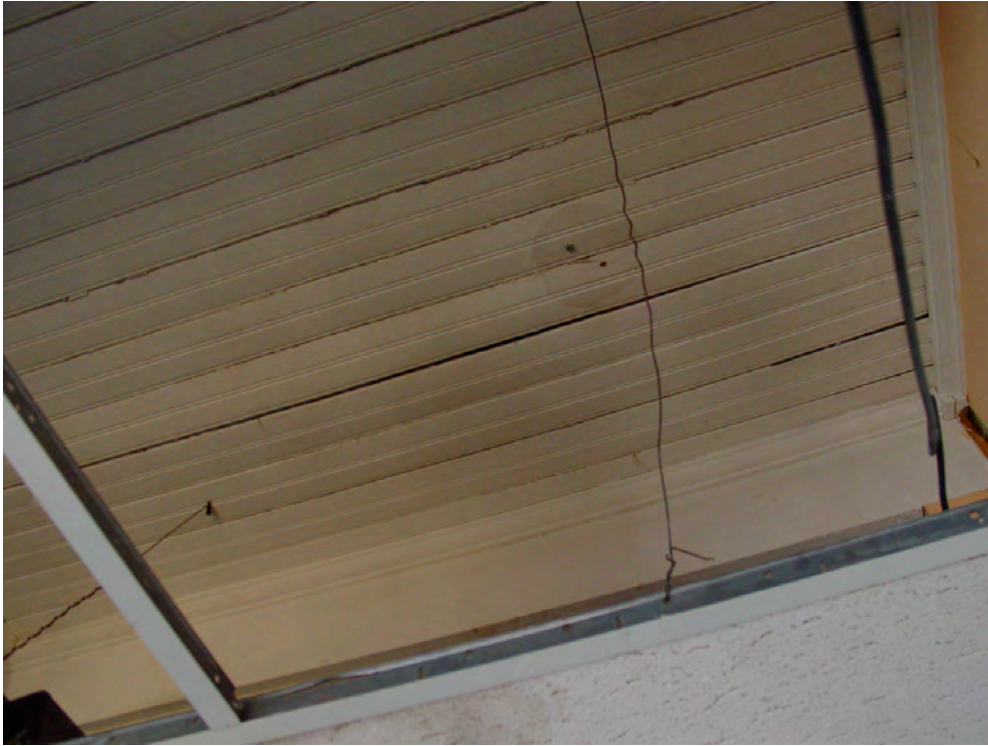
Above the suspended ceiling in the Fair Office, there is extensive evidence of roof leakage at the ceiling and the partitions, both surfaces consisting of bead board painted white.

IC-2c: Water damage to bead board ceiling.

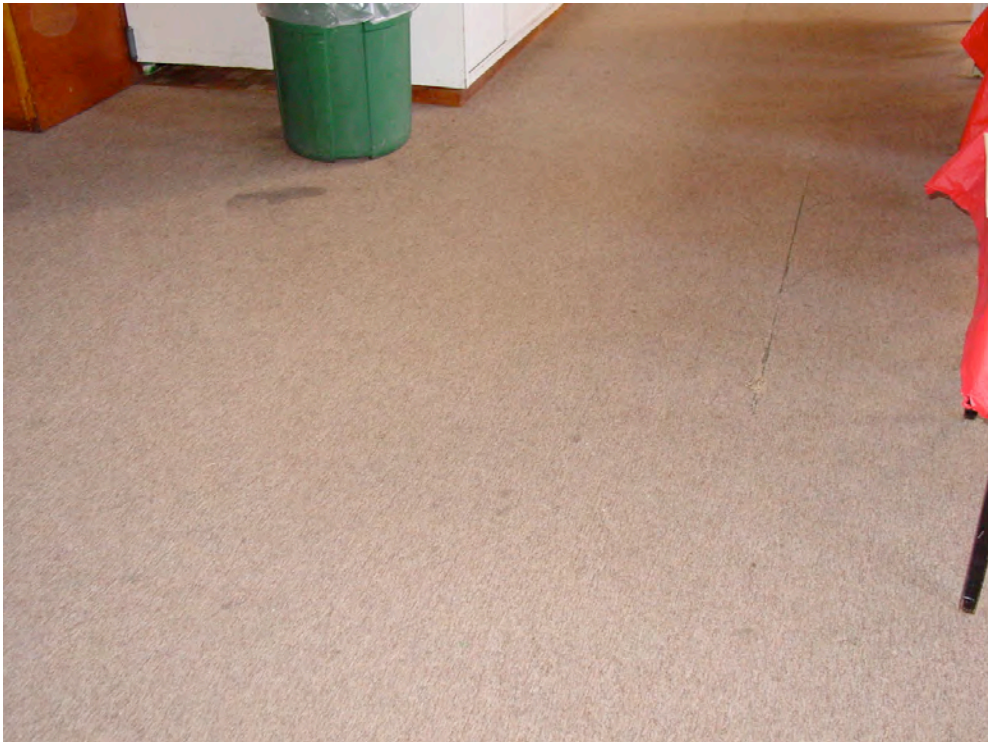
The first floor carpeting is stained and, in a few areas, torn.

IC-2d: Stains and tear in carpet in main assembly space.

Recommendations regarding the cupola leakage have already been made. The carpet replacement should be coordinated with the next interior renovation. The attached plans schematically show the recommended renovation.

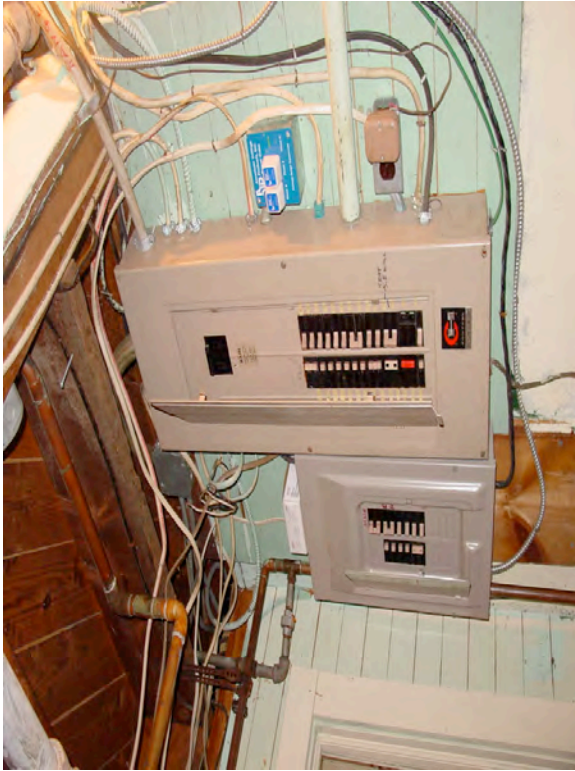
IC-3a: Electric panel in basement.

Recommendations: Upgrade the electric service capacity as part of the next renovation project. Paint the fluorescent strip fixtures to blend with the bead board ceiling.

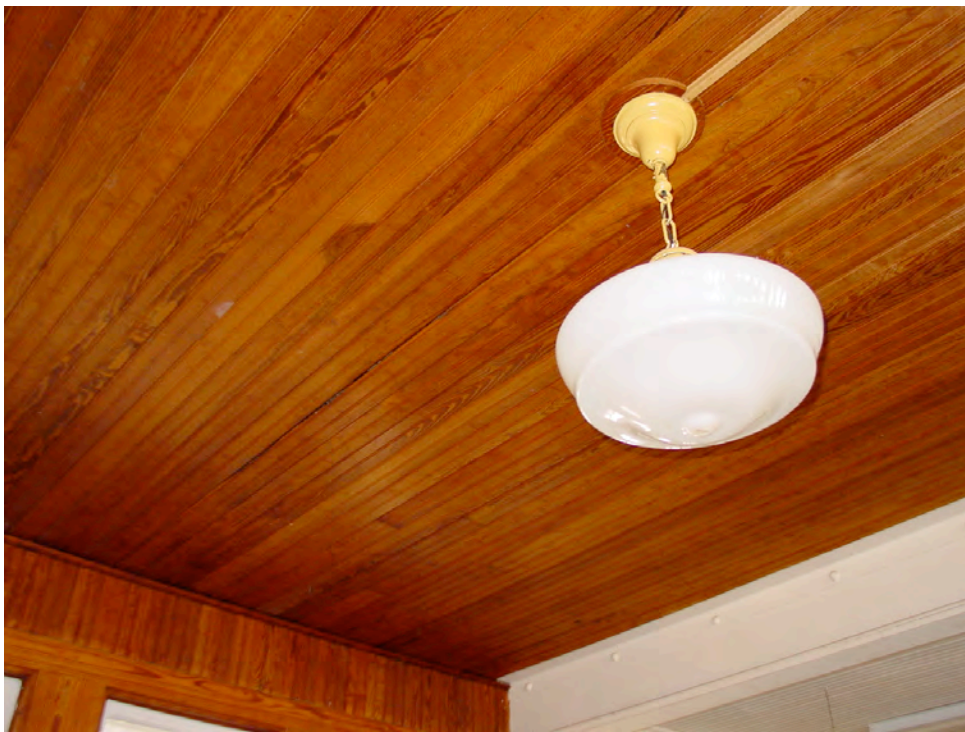
IC-3b: Schoolhouse light fixture in main assembly space.

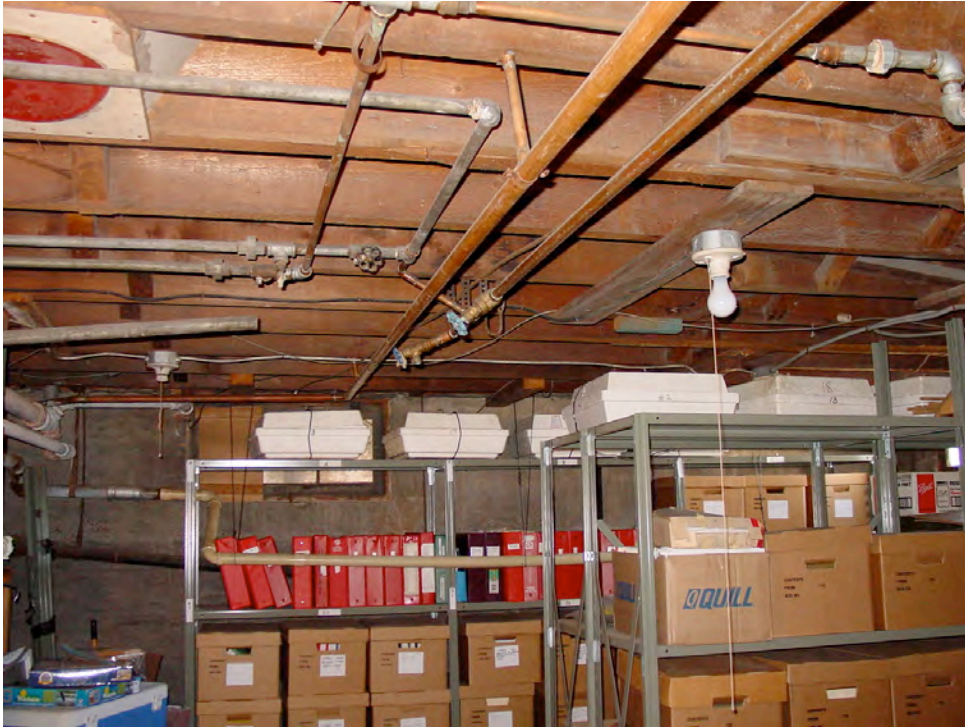
IC-4a: Basement plumbing, a mixture of threaded iron and soldered copper.

Recommendation: Continue to use the existing until renovation adds the new toilet rooms at the east end of the building. At that point, replace piping and connect new facilities with the municipal sewer system.

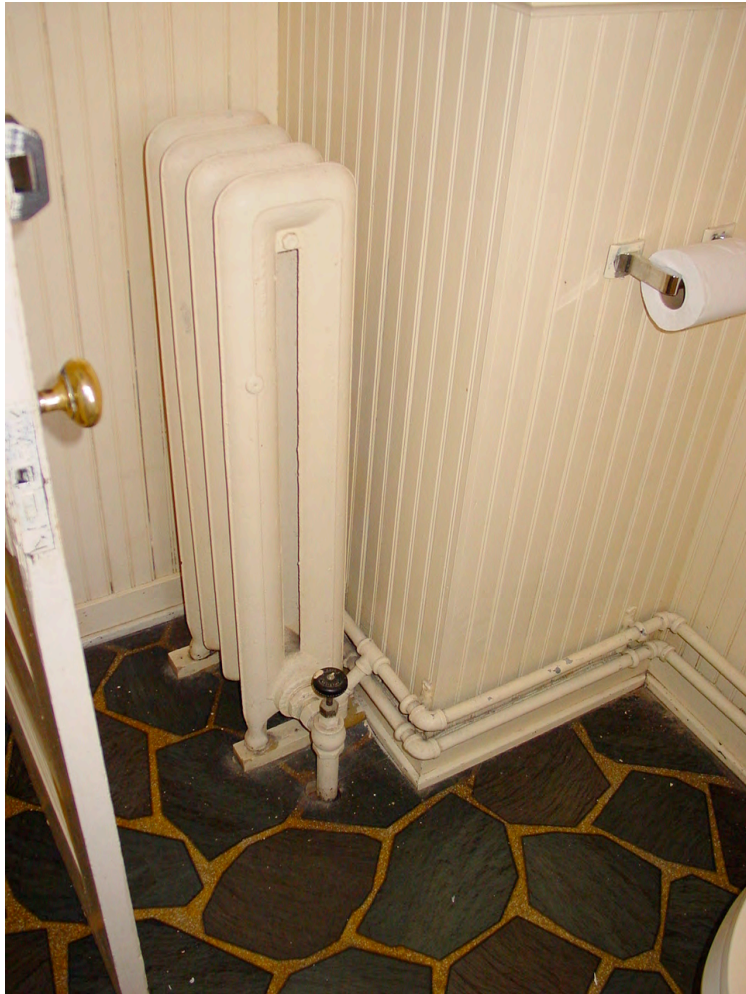
EC-5a: Single pipe radiator in second floor toilet room with exposed plumbing.

Recommendation: Eliminate and replace the three existing heating systems with a new water heating boiler and distribution system.

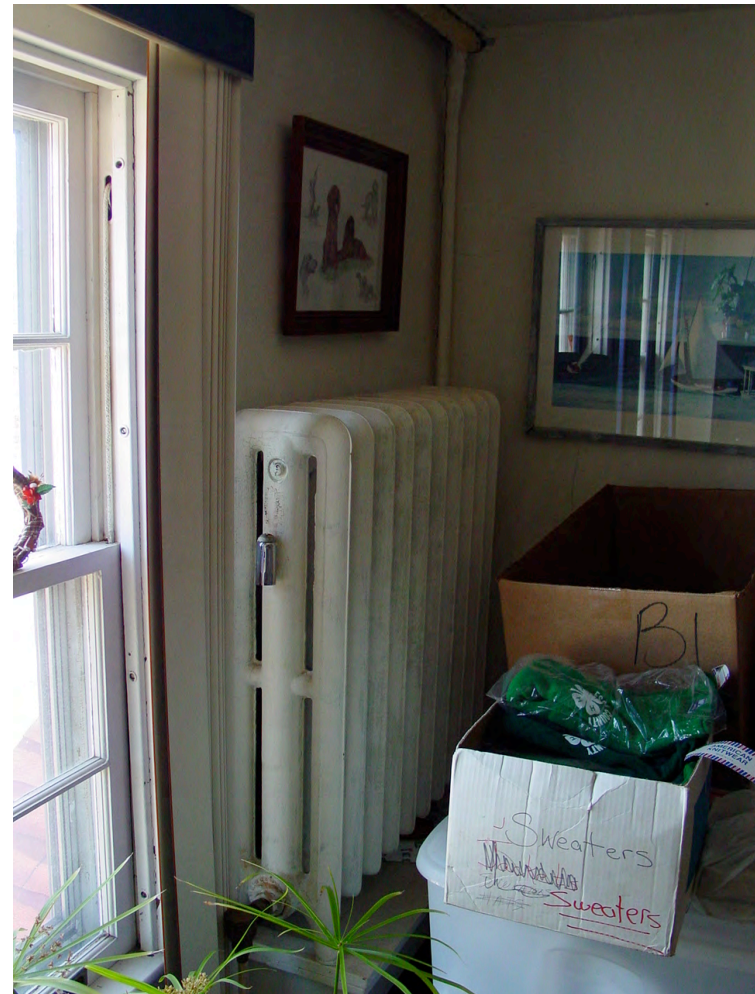
IC-5b: Typical steam radiator, elevated to improve condensate return.

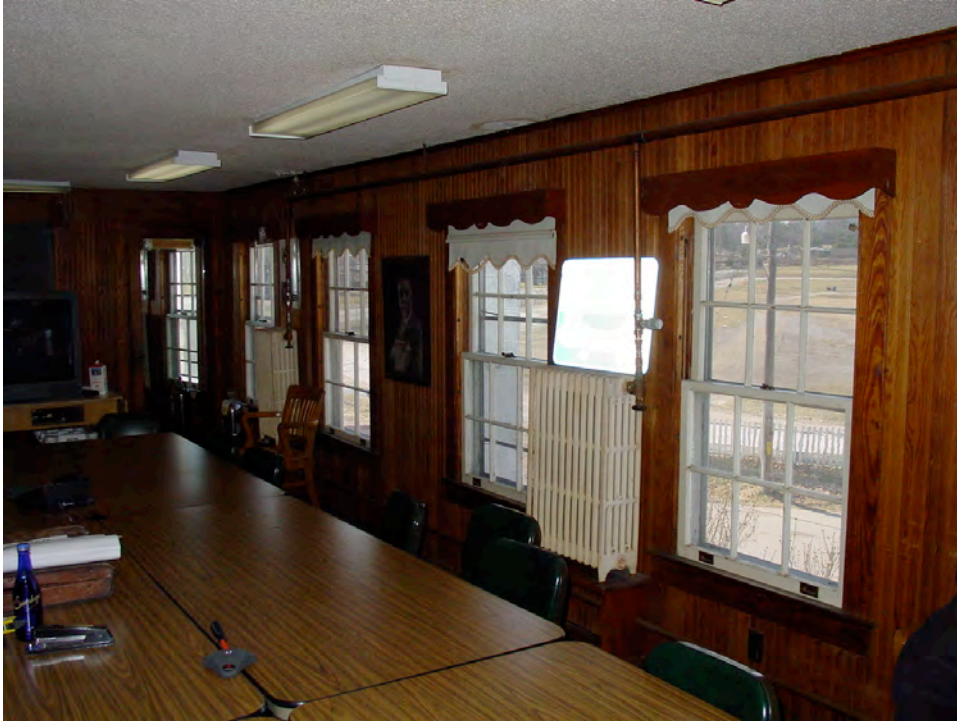
IC-5c: Radiators in current second floor meeting room, again, elevated to operate as a two-pipe system.

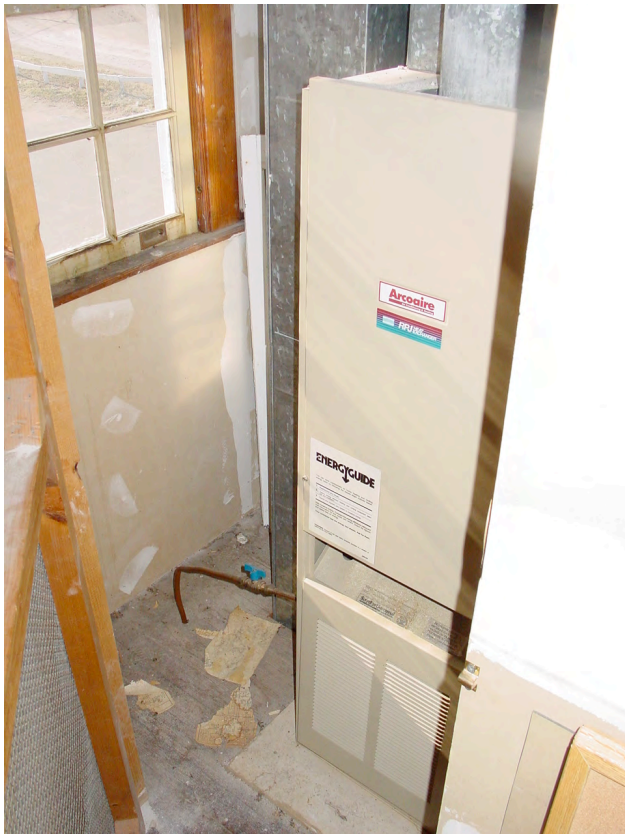
IC-5d: Furnace on second floor, west.

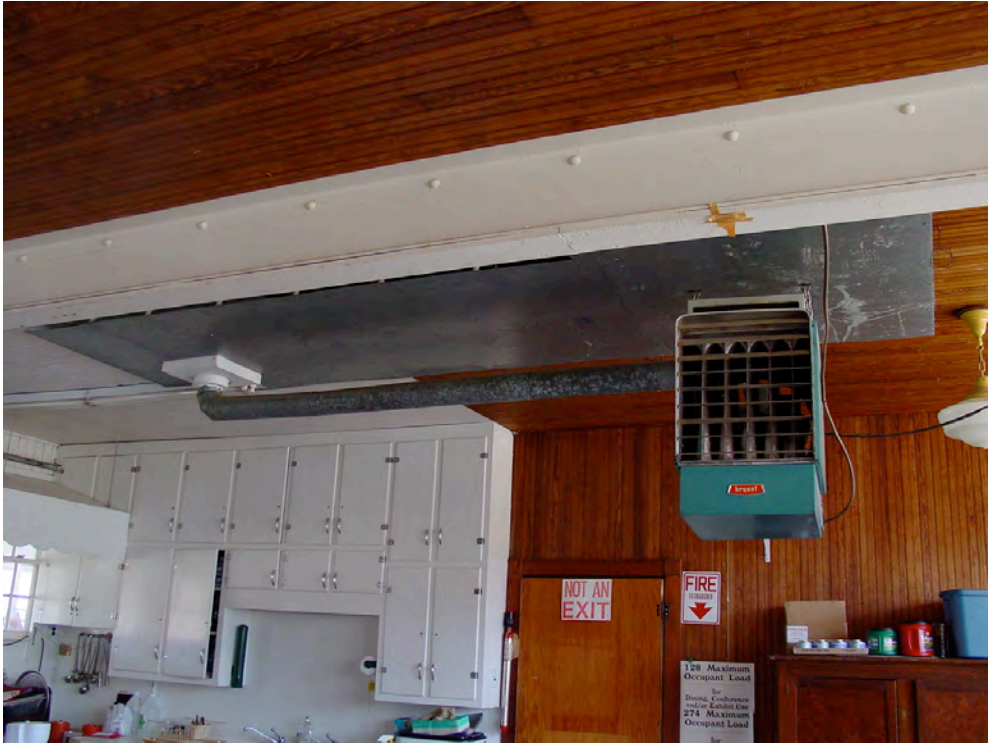
IC-5e: One of two propane heaters in main assembly space. Note metal shield over flue pipe on ceiling.

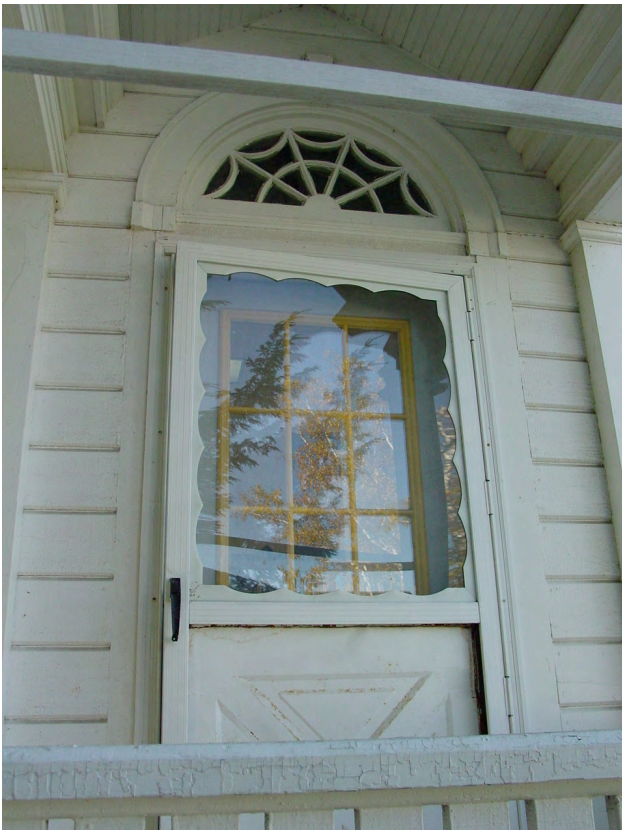
AI-2: Replacement door, exterior view.

Recommendations: Redevelop the interior of the back (north) porch to provide critically needed interior space without adversely impacting the exterior of the Agricultural Center Building. Paint the replacement sash doors white, inside and out, to better blend in with the historic building. Systematically replace these doors, starting with the rusted one at the northeast entrance, with wooden sash doors when renovation is accomplished in the respective portion of the building.

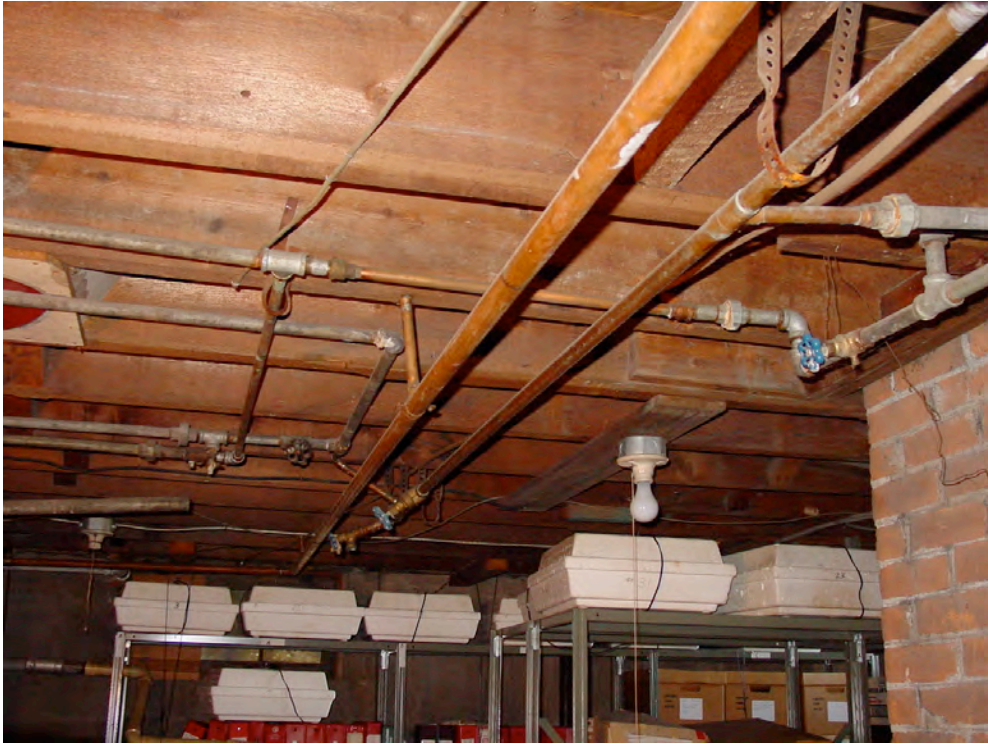
AI-7: Boiler room ceiling.

Recommendations: Architectural integrity is not an issue in this area. Rated enclosure of the boiler and improvements to storage facilities are contained in subsequent sections.

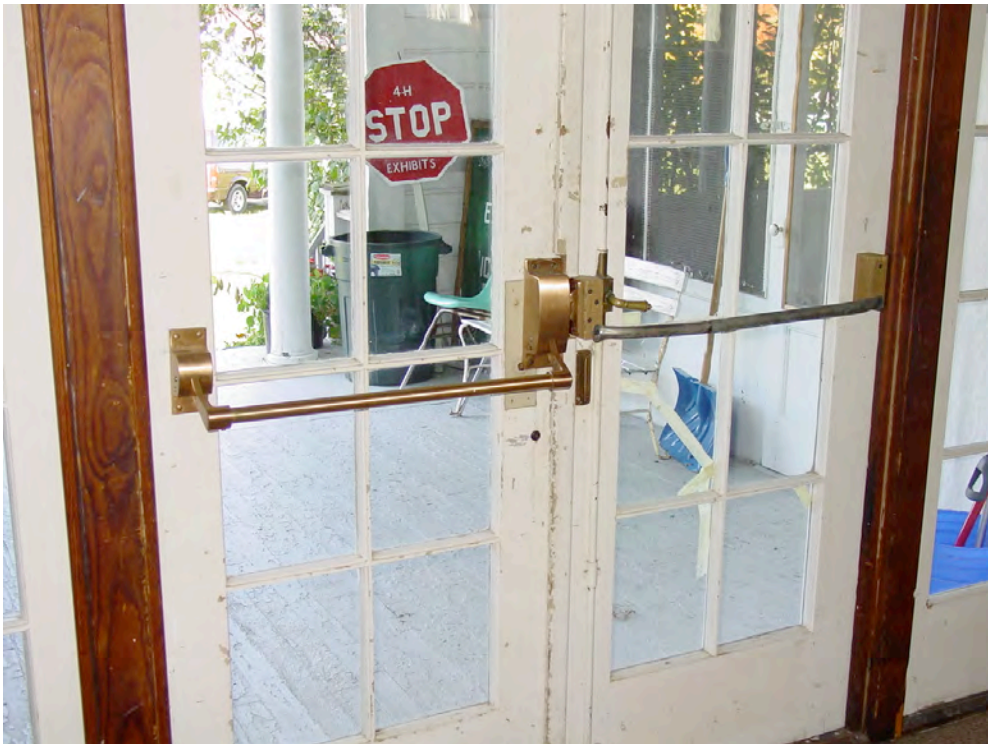
PR-1b: Assembly space, homemade hardware on inactive leaf of exit door.

Recommendations: After relocating the kitchen to the east, per the attached proposed floor plans, rehabilitate the main space with two folding partitions and attendant modifications to doorways. Improve the fire exit bolt door hardware.
