MASTER PLAN

AGRICULTURAL CENTER BUILDING ESSEX COUNTY CCE OFFICES

WESTPORT, NEW YORK

DECEMBER 2005

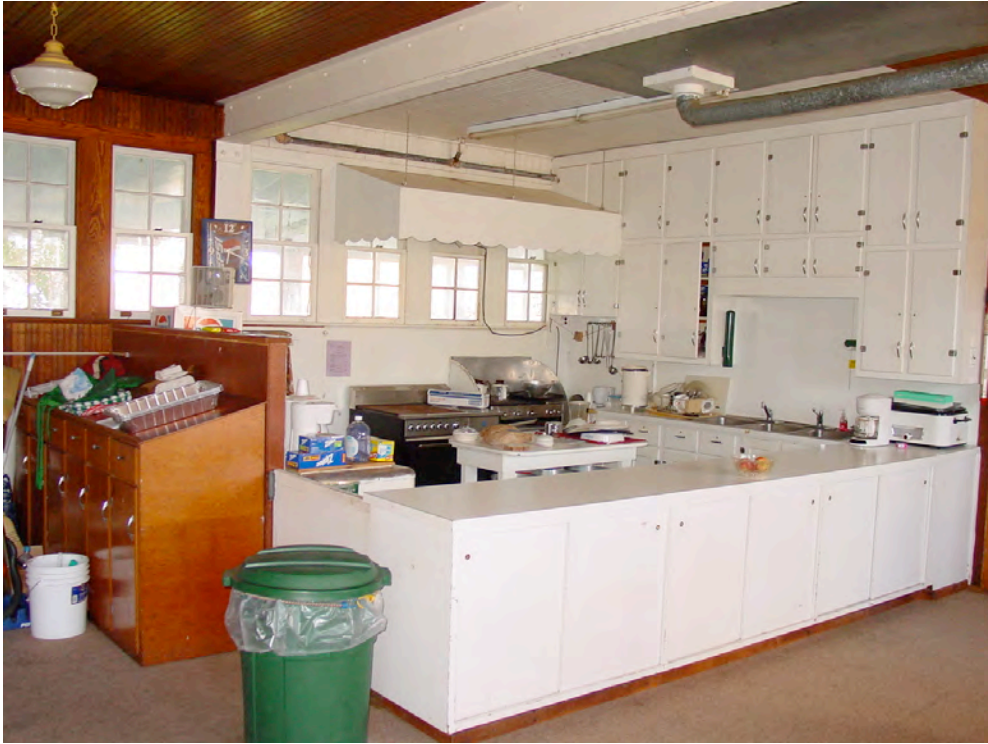
PR-4: The kitchen, as is, with no separation from the main space.

Recommendation: Relocate the kitchen as shown on the proposed floor plans to the current Fair Office in the northeast corner of the first floor. Provide the required fire separation between new kitchen and the assembly space.
