PROPOSED WORK SCOPE
WITH
STATEMENT OF POSSIBLE CONSTRUCTION COSTS

FOR REHABILITATION OF THE
AGRICULTURAL CENTER BUILDING
ESSEX COUNTY FAIRGROUNDS
WESTPORT, NEW YORK

PREPARED FOR:
CORNELL COOPERATIVE EXTENSION - ESSEX COUNTY
PO BOX 388, 3 SISCO STREET
WESTPORT, NEW YORK 12993

PREPARED BY:
CRAWFORD & STEARNS
ARCHITECTS AND PRESERVATION PLANNERS
134 WALTON STREET
SYRACUSE, NEW YORK 13202

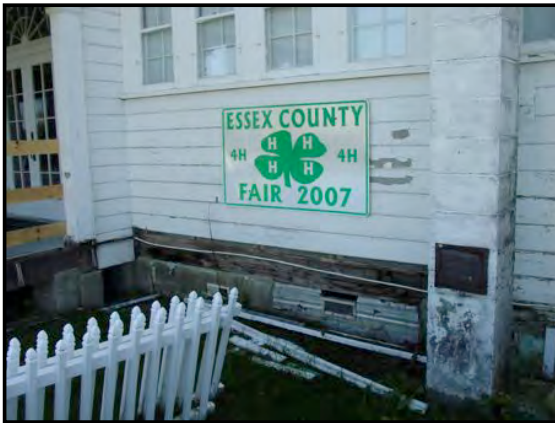
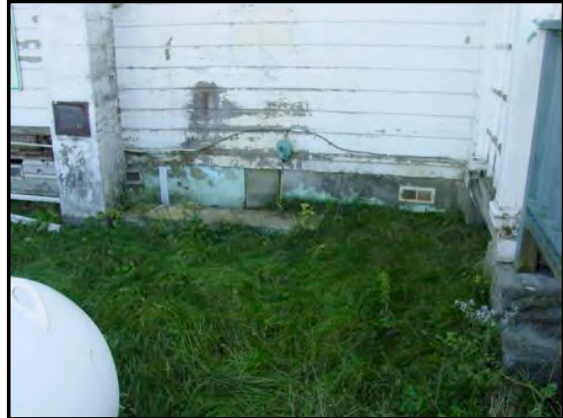
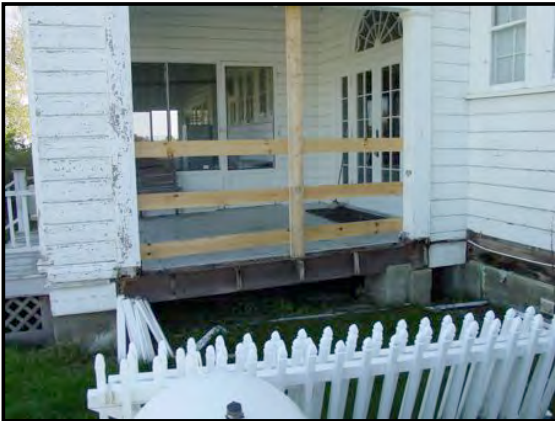
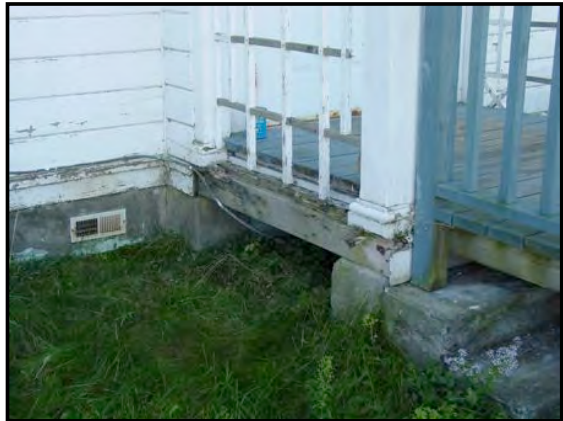
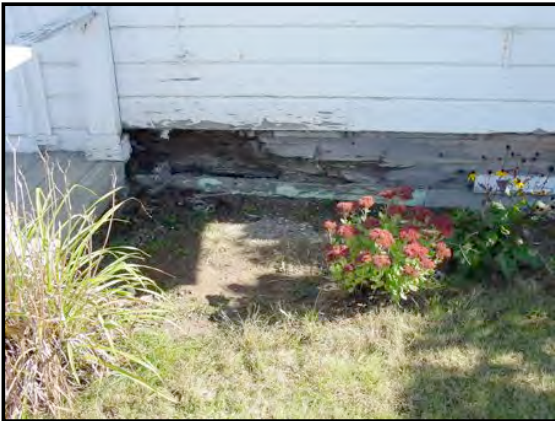
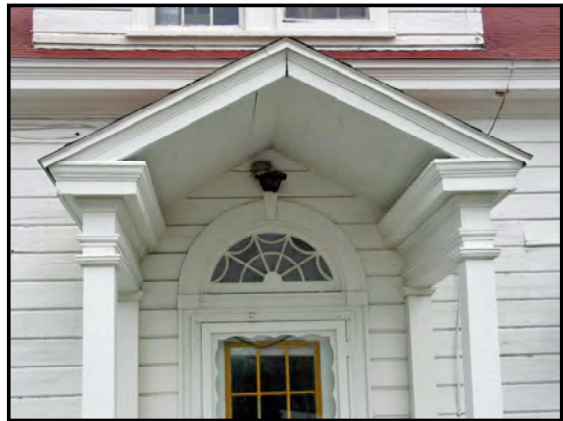
Work Scope 1: Structural Stabilization

- Upper views show left and right portions of north main façade with deteriorated sill plate. Concrete masonry unit chimney is obsolete and appears to have caused much of the damage by diverting water against the building.
- Middle views show the adjoining porch and portico decks respectively, also suffering from deterioration in framing.
- Lower left view illustrates even more advanced sill and framing deterioration at west façade where wall is at ground elevation and/or has been partially buried.
- Lower right shows spreading of gable peak in west portico.

a. Jack up and replace portions of north sill plate and repair wall and edge of first floor framing after removing the obsolete concrete masonry unit chimney; west wall. Two-story north wall: 23 l.f. and west wall 7 l.f.	
Frame repair with jacking @ north & west elevations 30 l.f. @ \$500/l.f. =	\$15,000
b. Install portico tie rods: 4 each @ \$1,500/each =	\$6,000
c. Install plywood sub-sheathing at first story	
23'w x 6'h = 138 north and 7 west, say 150 s.f.	
+ New insulation: 150 s.f.	} 150 s.f. at } \$15.00/s.f. =
+ Rain screen furring: 150 s.f.	
+ Chamfered T & G siding: 150 s.f. @ \$40/s.f. =	\$6,000
+ Prime and paint: 23' x 12' = 276 say 300 s.f. @ \$2.50/s.f. =	\$750
d. Install temporary handrail at north portico.	\$1,000
e. Have building treated for insects.	\$2,000
	\$33,000

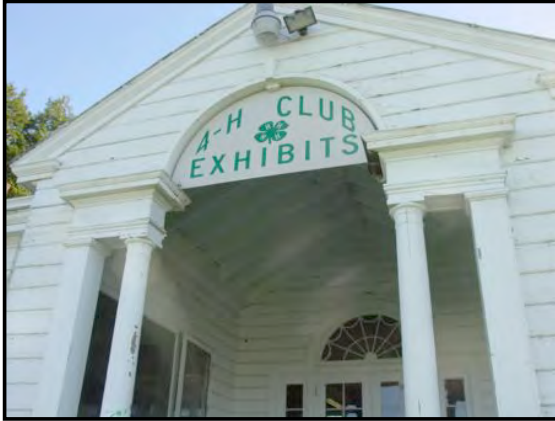
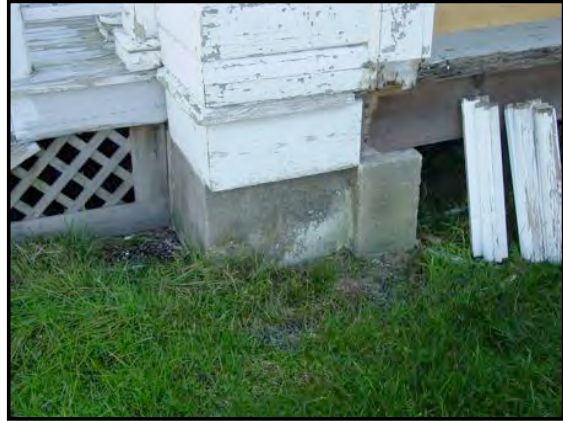
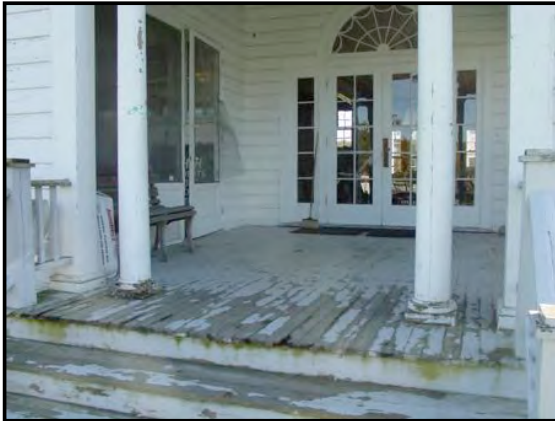
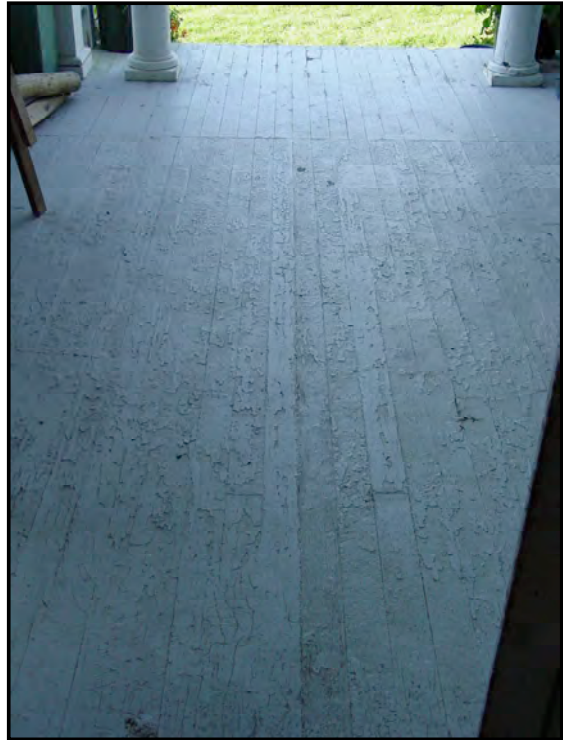
Work Scope 2: Porches and Portico Restoration

- All photographs show north porch deterioration.
- Left views illustrate portico damage.
- Upper right photograph shows sill deterioration.
- Lower views illustrate floor deterioration with previous repair line.

b. Replace standing seam metal roof on 45 s.f x 13 s.f. north porch, north portico and east-facing ice apron:	
585 s.f., say 6 squares 15 x 18 = 270, say 3 squares 34 x 2 = 68, say 1 square = 10 squares @ \$300/s.f. =	\$30,000

c. Restore all exterior components in all six entrance porticos	
Roof edges: crown molding, fascia, planceer, bed & frieze 30' south, 20' west, 20' east, 20' southeast, 35' north = 125 l.f. @ \$500/l.f. =	\$62,500
Columns/caps/bases Round columns: 4 ea., replace in kind, @ \$3,500/each = Square columns & pilasters: 14 ea., repair bases & caps @ \$750/each =	\$14,000 \$10,500

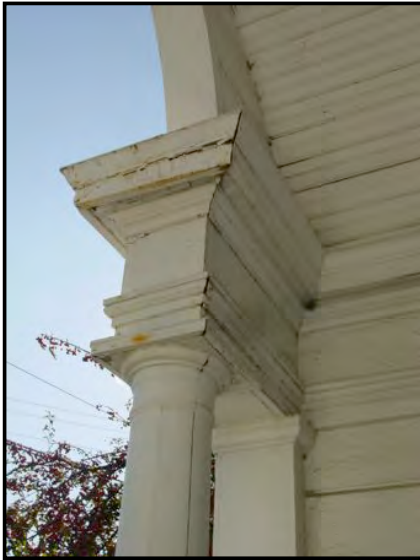
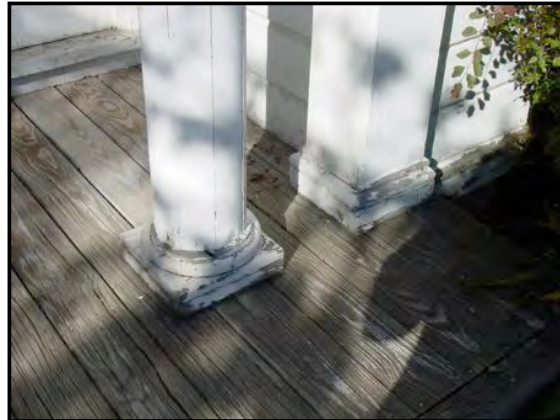
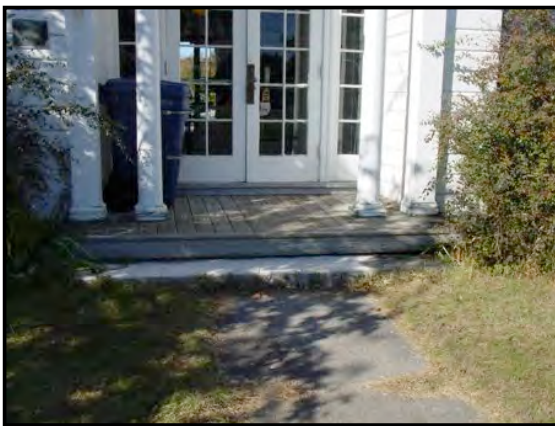
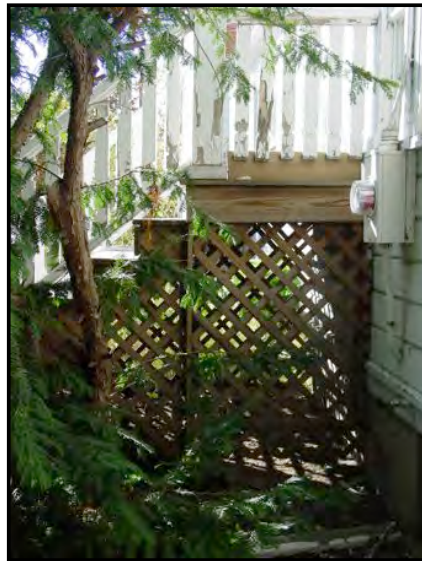
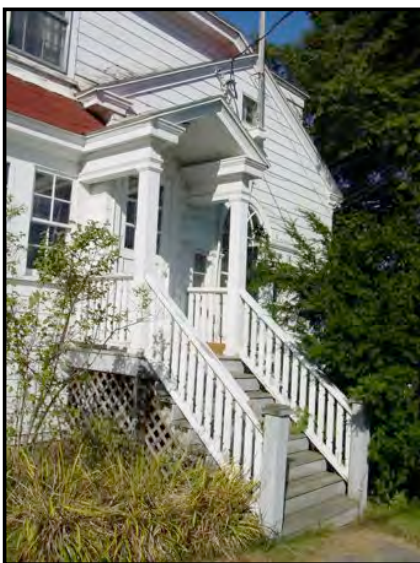
Work Scope 2 Continued: Porch and Portico Restoration

- Upper views show portico deterioration at south main entrance.
- Middle left illustrates concrete stoop, which has been patched.
- Middle right and lower left views show right portico and stairway to south elevation, near the copy room. Deck, stairs and trellis panels have been replaced in unpainted pressure-treated lumber. Railing balusters match those removed from the north porch.

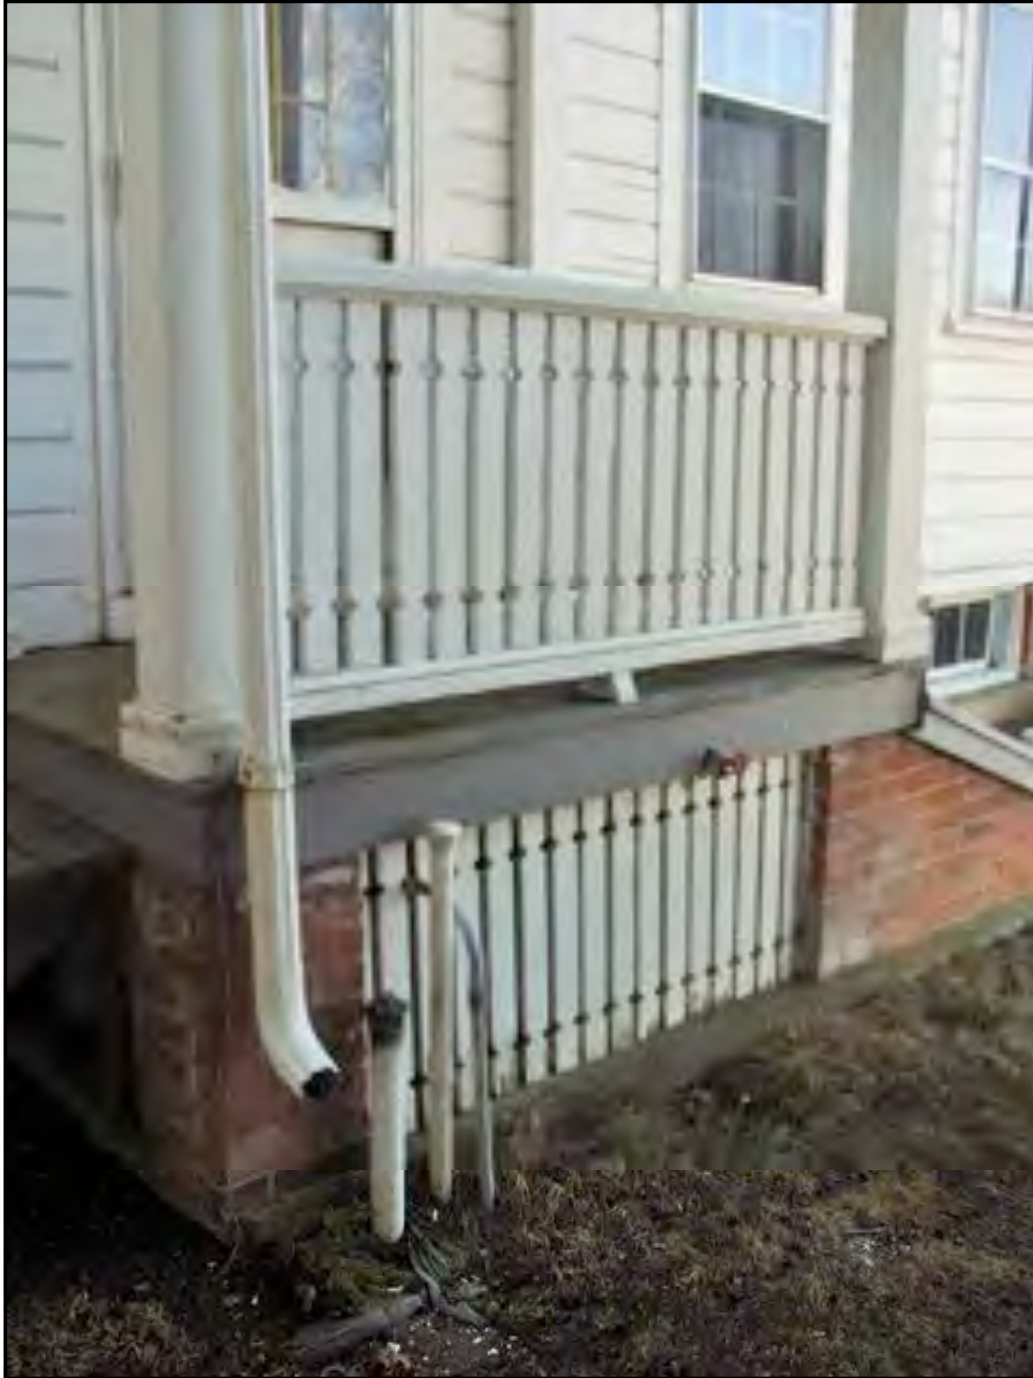
Work Scope 2 Continued: Porch and Portico Restoration

- East entry porch, illustrating original baluster design.

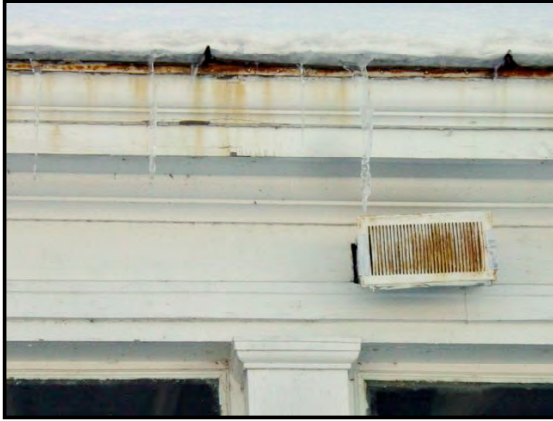
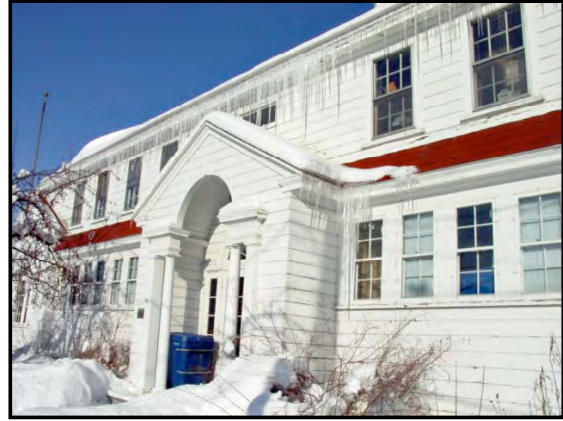
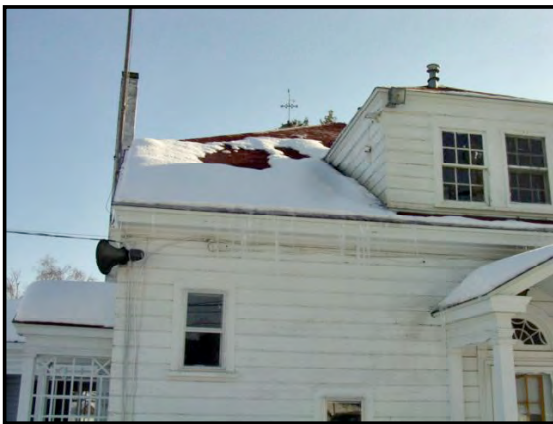
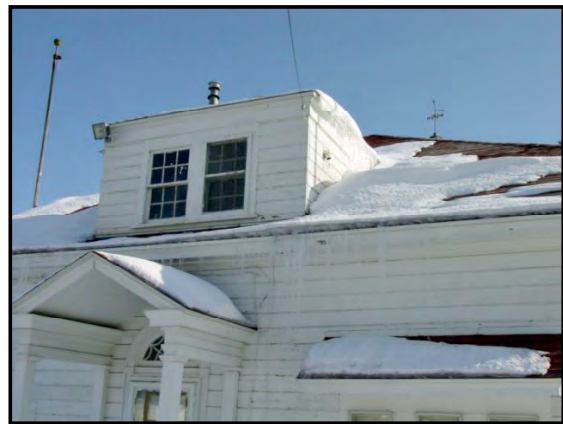
Work Scope 3: Attic Improvements

- Upper views: ice build-up on roofs at horizontal eaves.
- Lower views: west main roof hip with dormer and snow melting due to air exfiltration in the main attic and secondary roof voids.

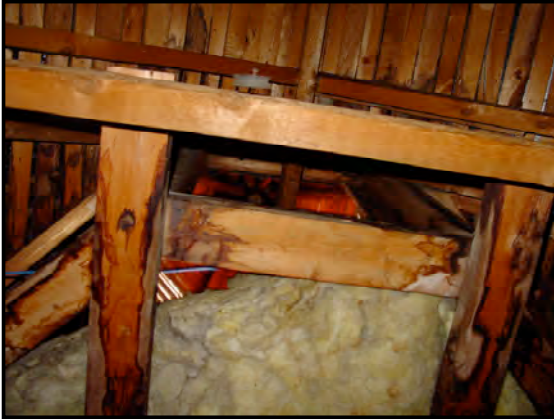
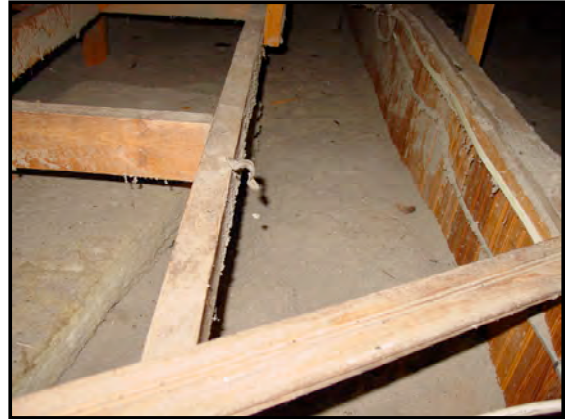
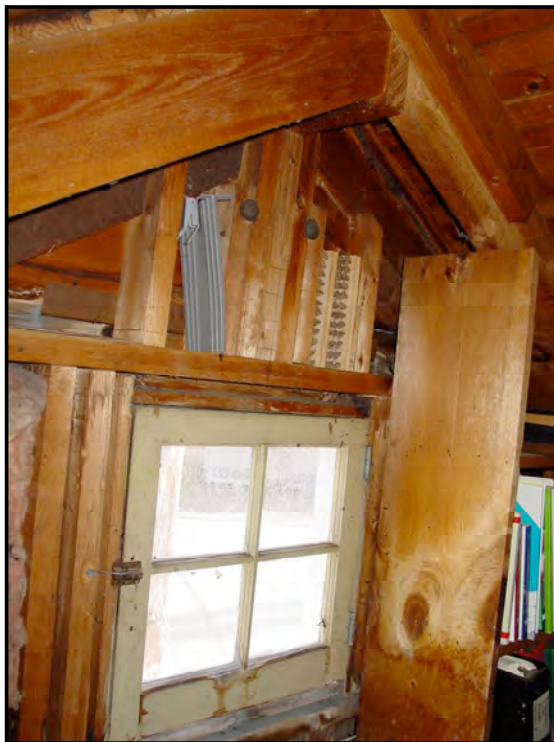
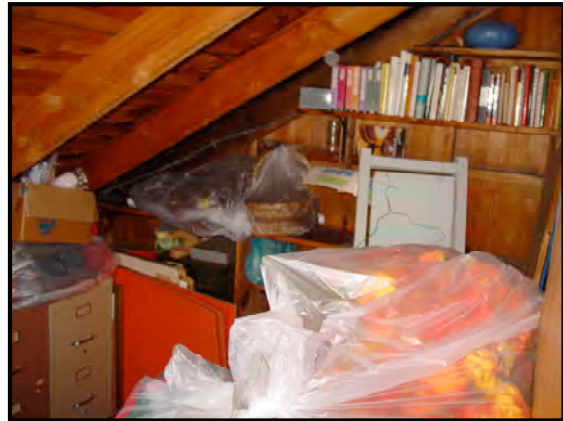
Work Scope 3 Continued: Attic Improvements

- Upper left: water stains from cupola leakage.
- Upper right: original beadboard partition rising above cellulose insulated false (suspended) ceiling.
- Lower views: unfinished west attic.

a. Vent the main roof void by introducing chute channels and air intakes in the roof cornice soffits:	
(30 x 2) (92 x 2) = 60 + 184 = 244, say 250 l.f. @ \$15/l.f. =	\$3,750
b. Make the cupola louvers watertight by adding a fillet at the top of each vane.	
8 facets x 12 vanes - 96 ea. say 100 ea.	\$3,000
Repair cupola, restore finial and four flag staffs	\$2,500
c. Upgrade the small southwest storage attic by insulating from the inside and installing a beadboard finish.	
9' x 11' plan room = 99 s.f., say 100 s.f. ceiling and 50 + 50 s.f. walls = <u>100 s.f.</u> 200 s.f. @ \$30/s.f. =	\$6,000
	\$15,250

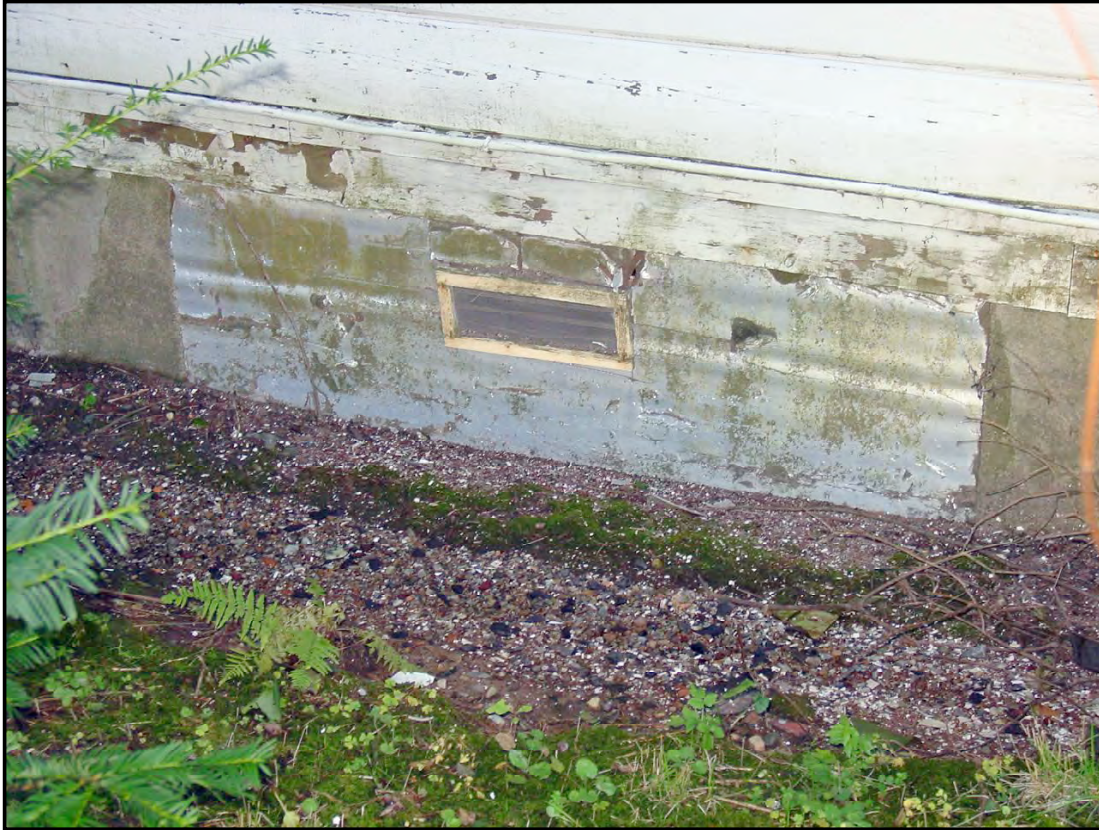
Work Scope 5: Crawl Space

- Whether or not either option under Work Scope 4 is selected, the crawlspace, which extends beneath 85% of the Agricultural Center Building, needs some changes, especially at the building perimeter.
- Drawing A•7.2 has been keyed to show the perimeter.

a. Utility corridor: See "Basement Extension or Utility Corridor" section above.	
b. Replace perimeter skirting. 2 x 60 l.f. = 120 l.f. @ \$75/l.f. =	\$9,000
c. Re-insulate first floor deck and install protective layer. 30' x 60' = 1800' @ \$5/s.f. =	\$9,000
d. Either provide additional ventilation as recommended in the structural review or conditioning of the air therein must be provided. 1,800 s.f. @ \$20/s.f. =	\$3,600
	\$21,600

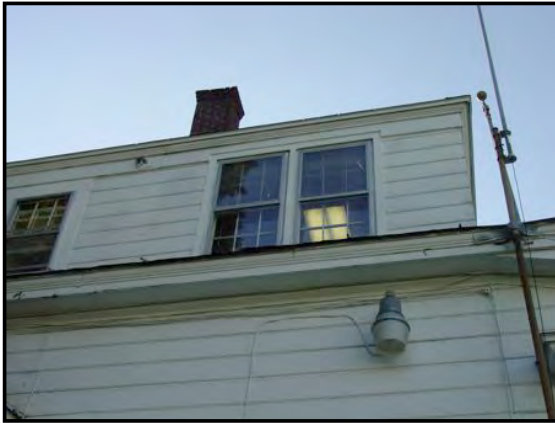
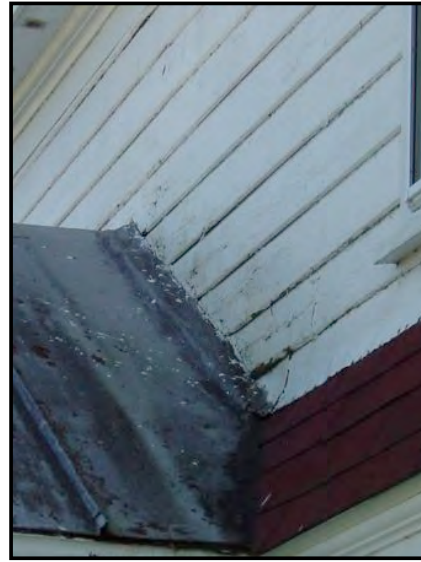
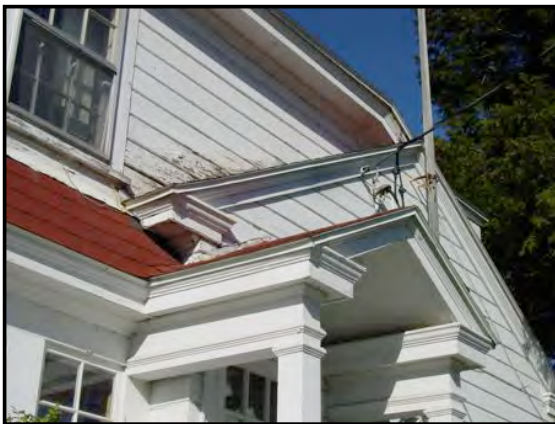
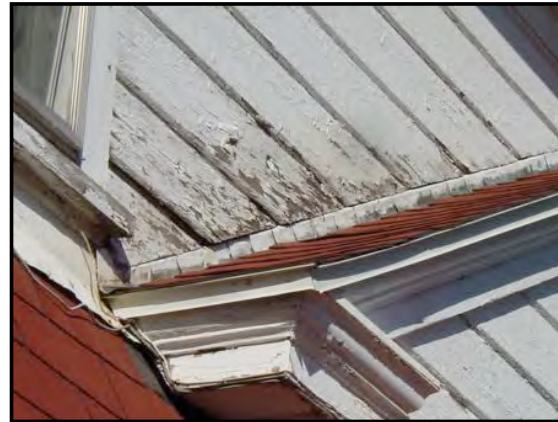
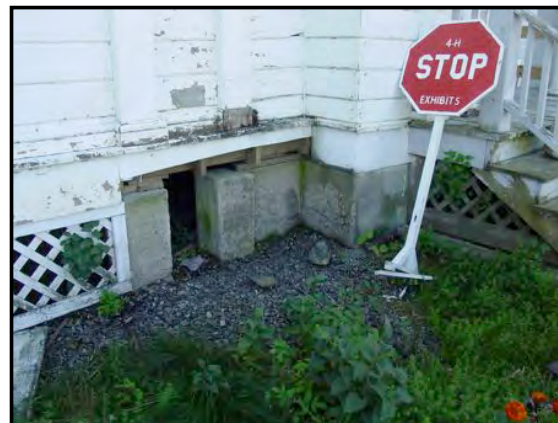
Work Scope 6: Façade Restoration

- All photographs on this page illustrate deterioration to paint and siding caused by rain splash from eaves above. They also show cornice moldings, which also need increased protection and/or increased maintenance.
- Upper left view gives evidence that the east shed dormer has been extended north and south to three times its original width. The evidence is both in the mitered cornice joints and in the rough-sawn surface of the chamfer siding. The original is vertically sawn, while the later is circular sawn.
- The lower views show moisture damage at or near ground level.

<p>a. Rehabilitate siding: west 550 s.f., east 650 s.f., north & south 160' x 13'h minus windows @ 4'h = 9'h = 1,440 + 1,200 = 3,840 s.f. @ \$40/s.f. =</p>	\$200,000
<p>+ Record siding with pencil marks on trim and carefully remove. + Re-insulate exterior walls. + Install plywood sheathing. + Install rain screen and reflash roof to wall intersections. Reflash: 10 short intersections @ 5' = 50 l.f. 8 long intersections @ 10' = 80 l.f. 130 l.f. @ \$50/l.f. =</p>	
<p>+ Re-install novelty siding, prime and paint.</p>	\$6,500
<p>b. Restore all trim by replacing deteriorated and damaged portions only. (200 x 2) + (70 E + 5 W x 2) = 550, say 600 l.f. of which 10% is deteriorated = 60 l.f. @ \$150/l.f.</p>	\$9,000
<p>c. Rehabilitate windows: 31 up + 55 down = 86 ea. + 7 transoms</p>	\$3,600
<p>+ Label and remove sash and storm panels + Repair frames and sills + Paint + Reinstall sash + Reinstall storm panels Aluminum combination up. Wooden sash down 86 windows @ \$300/each = 7 transoms @ \$300/each =</p>	\$25,800 \$2,100

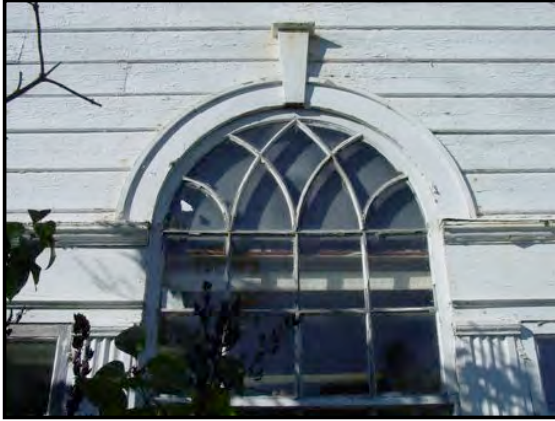
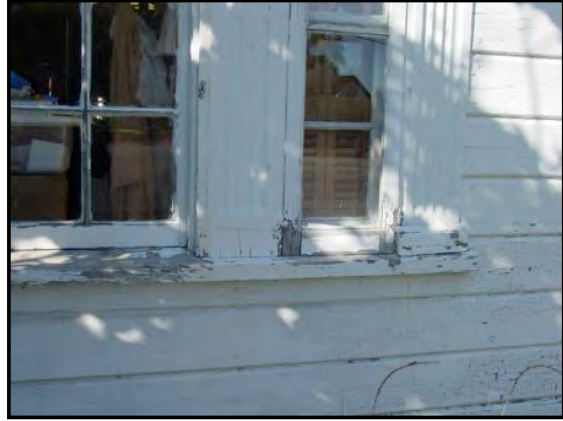
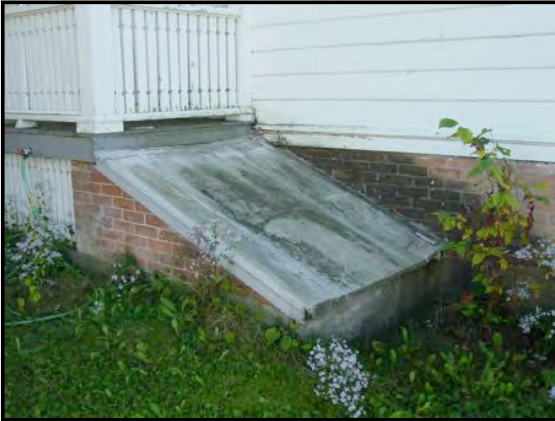
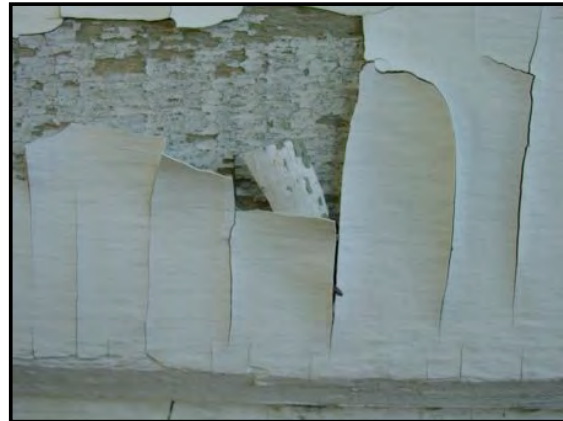
Work Scope 6 Continued: Façade Restoration

- Upper views show windows that are basically sound but which need an increased level of maintenance. These windows are important to the Colonial Revival style of the building.
- Lower left photograph illustrates deteriorated condition of metal-clad wooden bulkhead (exterior door to basement).
- Lower right view shows paint deterioration and indicates that the siding may have been gray years ago.

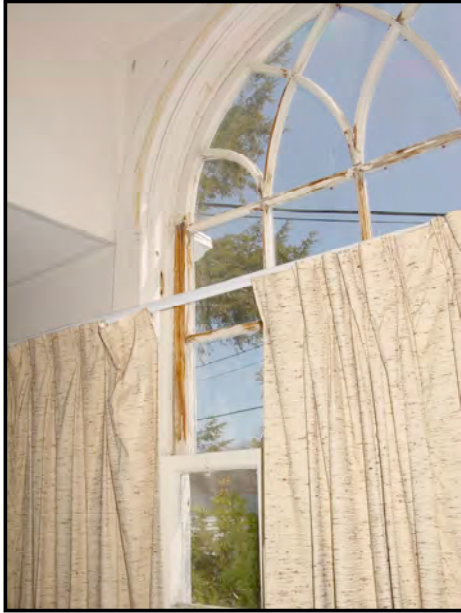
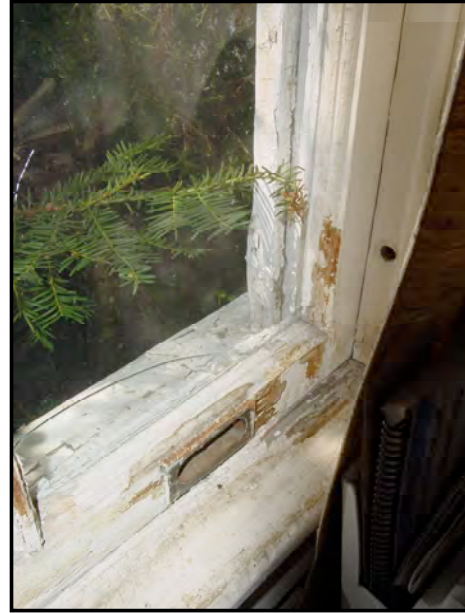
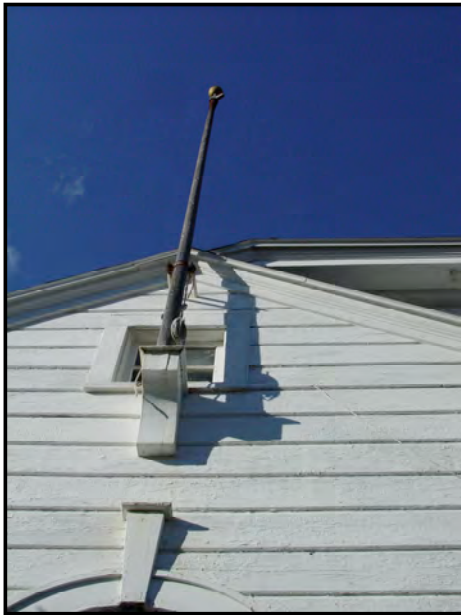
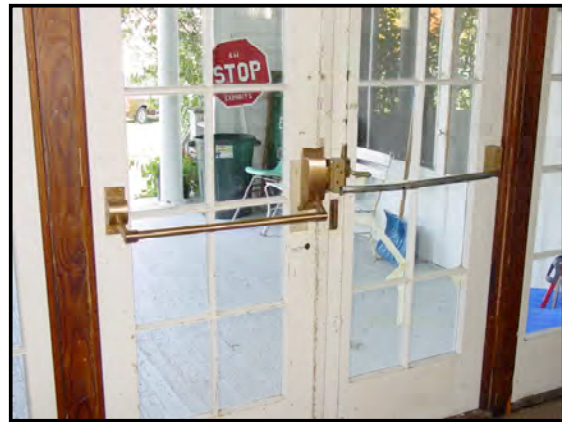
Work Scope 6 Continued: Façade Restoration

The repair and painting of the interior portions of wooden window systems are critical to façade restoration.

- Upper views show details of Colonial Revival windows.
- Lower left shows example of flagpole.
- Lower right illustrates need for hardware improvements.

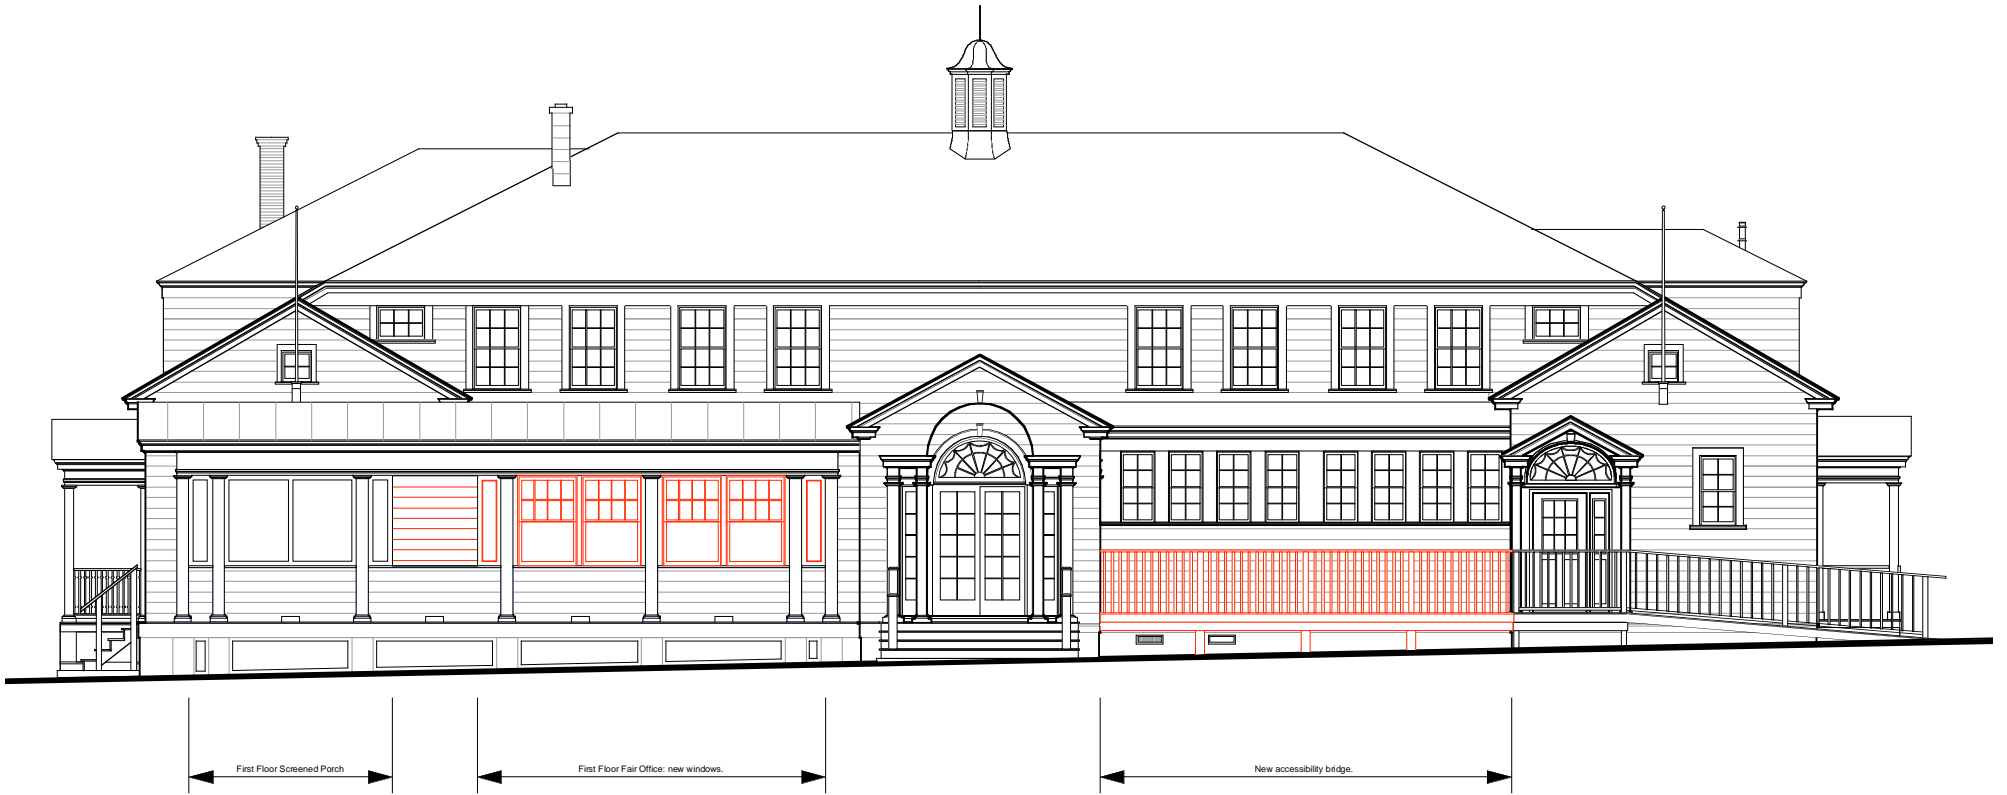
1
A•10 Proposed North Elevation
3/32" = 1'-0"

New construction
Note: Other new elements, such as doors, windows, stairs...etc. are indicated in "red".

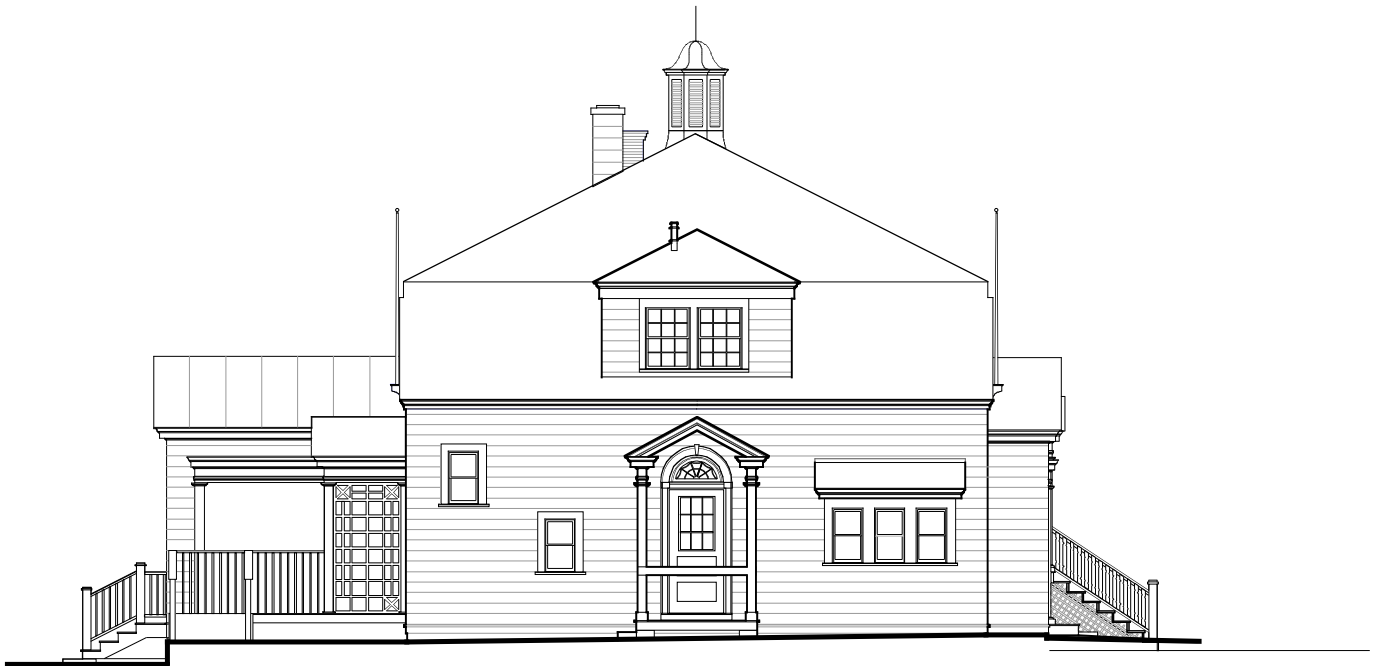
2
A•12

Proposed West Elevation

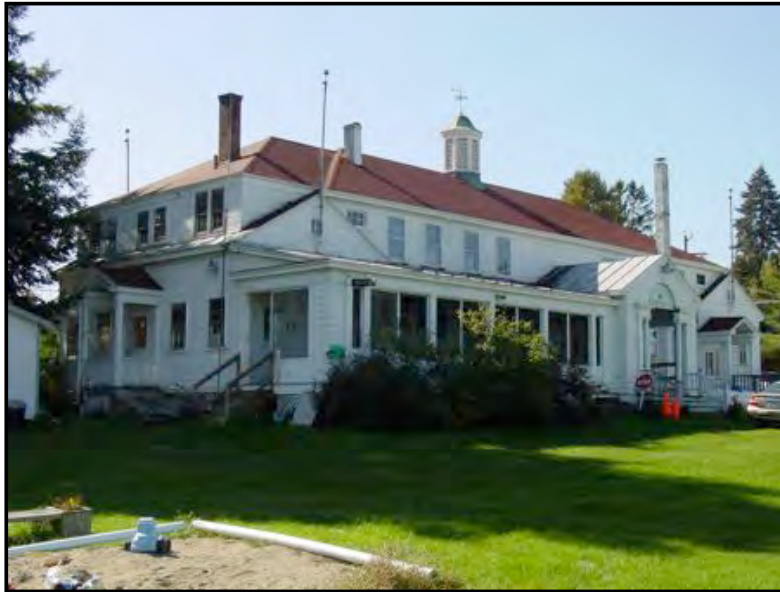
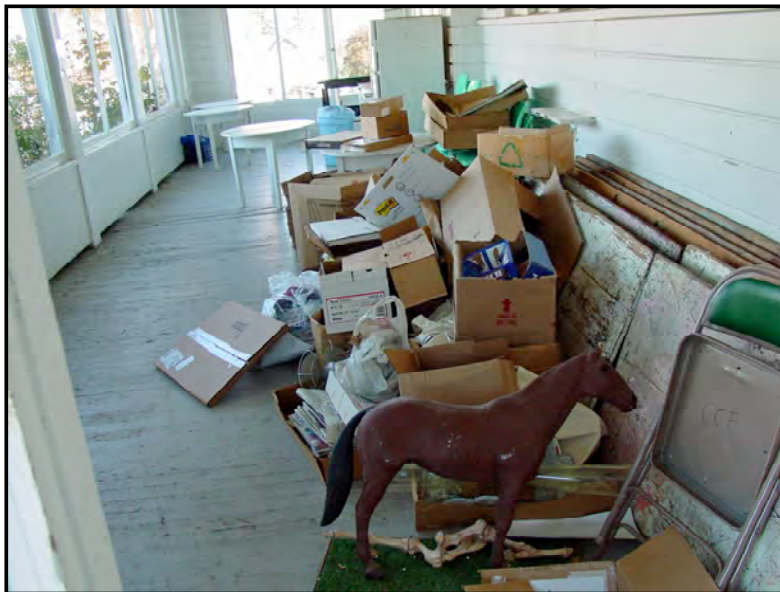
Work Scope 7: North Porch Conversion

- Upper photograph shows the porch from the eastern portion of the fairgrounds.
- Lower shows porch deck with clutter.

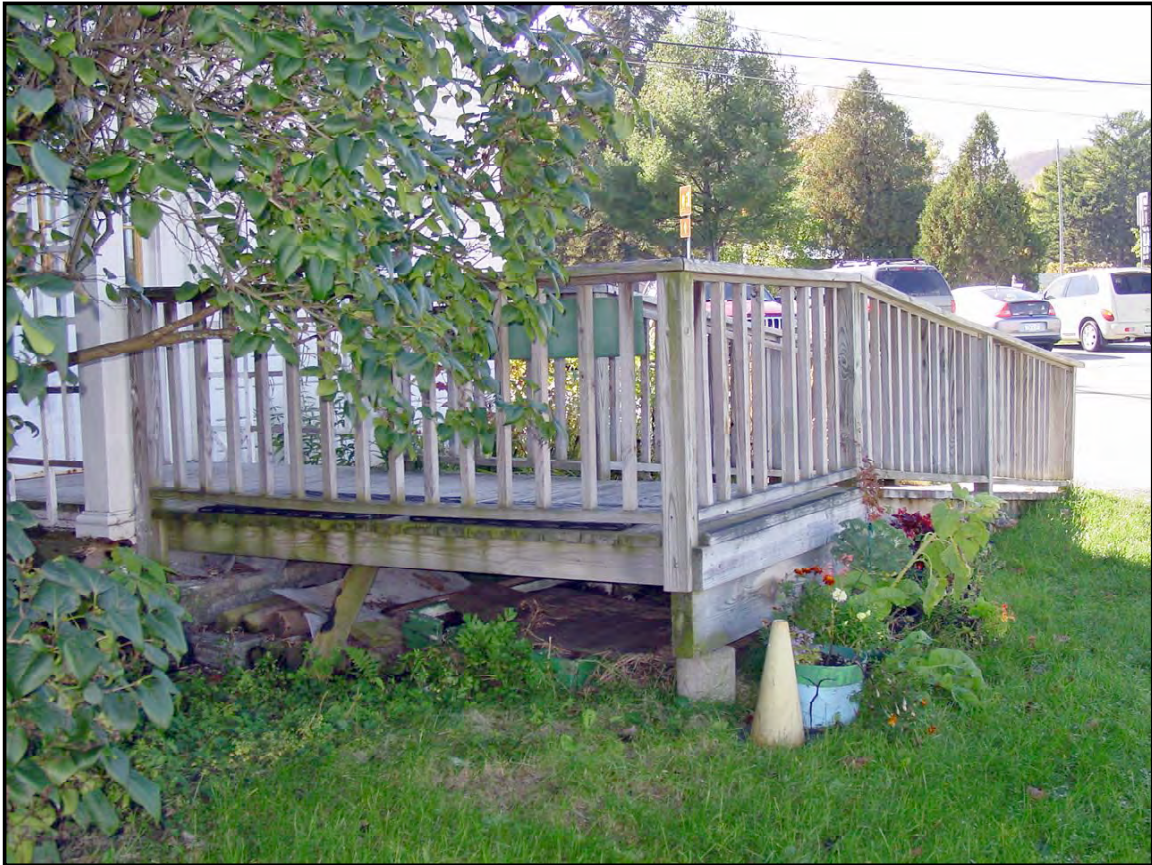
Work Scope 8: Accessibility

- Plan A•8 shows two important elements of recommended accessibility improvements. Similar to the Chenango County C.C.E. offices, this building accommodates the public on both floor levels. The former is also in an historic building, considerably older than Essex County's, and its lift was installed in 2004.
- Drawing A•8 shows a lift location.
- Drawing A•8 also shows a proposed bridge (elevated walkway) connecting the existing ramp with the north porch and hence, the first floor assembly space.

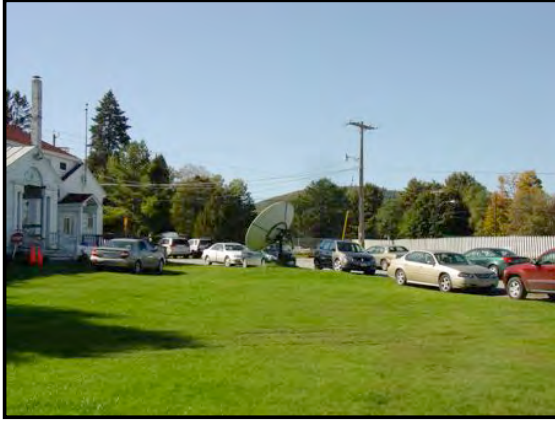
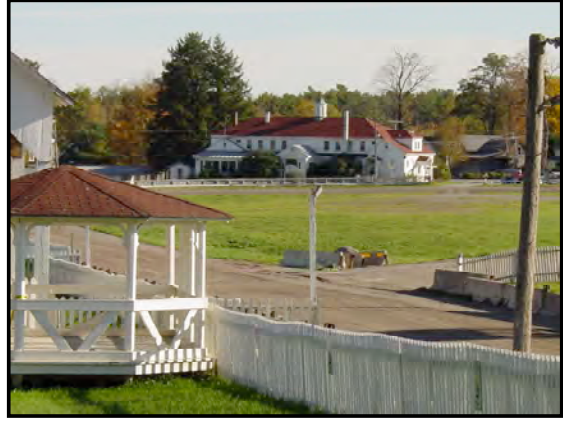
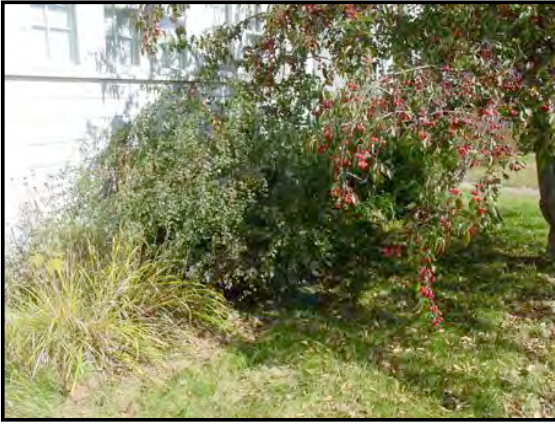
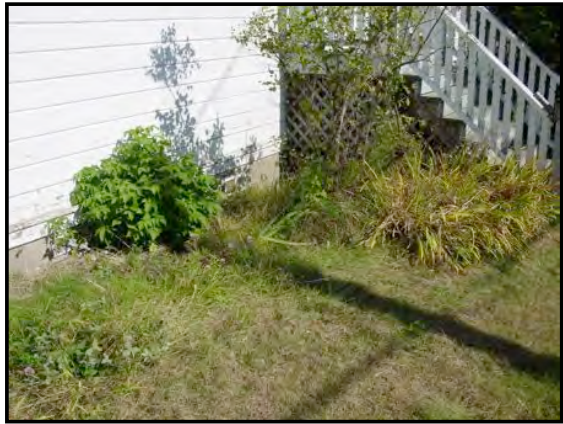
Work Scope 9: Site

- Upper view shows the back yard with parked cars strung out along the driveway, which circumnavigates the dirt racetrack. The satellite dish is also very visible.
- Lower photographs show the degree to which the vegetation around the front of the building is overgrown. The photograph in Work Scope 7 similarly shows the mass of foundation plantings at the north porch.

a. Document and cut back vegetation. 16 man-hours @ \$30/hour =	\$480
b. Reduce grade at west elevation and west half of south elevation. Have a contingency for archeological salvage. 16 hours of backhoe @ \$95/hour =	\$1,520
c. Install additional subsurface drainage piping beneath "drip line" of building and run to daylight. This is needed despite the installation of new eaves troughs, which is recommended.	
$92 + 32 + 92 + 14$ (porch offset) = 230 l.f. x \$60/l.f. = @ \$30/l.f. excavation & backfill + \$20/l.f. porous fill + \$5/l.f. geo fabric + <u>\$5/l.f. perforated pipe</u> \$60/l.f.	\$13,800
d. Restore lawns and foundation plantings	
Lawn 5,000 s.f. @ \$2.50/s.f.	\$12,500
Plantings	
12 shrubs @ \$300 ea.	\$3,600
2 trees @ \$500 ea.	\$1,000
e. Construct new walkway to center door. 500 s.f. @ \$20/s.f. =	\$10,000
	\$42,900

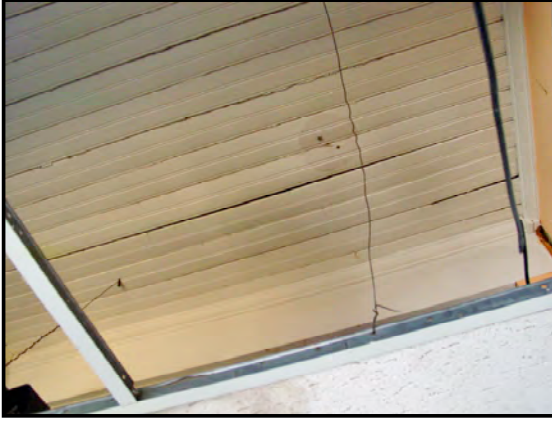
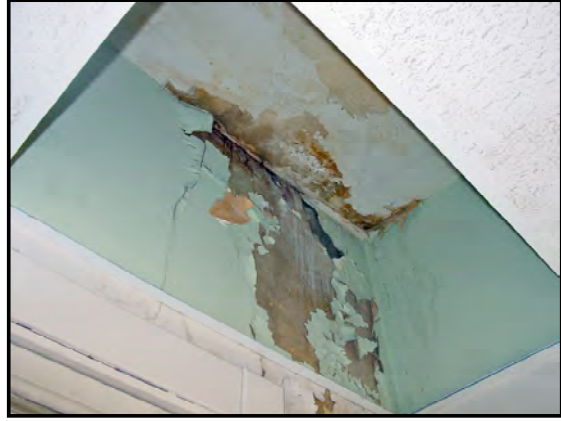
Work Scope 10 Continued: Restoration of spaces: Repair due to condition

- Left: Expose and restore period ceiling.
- Right: Repair and paint plaster.

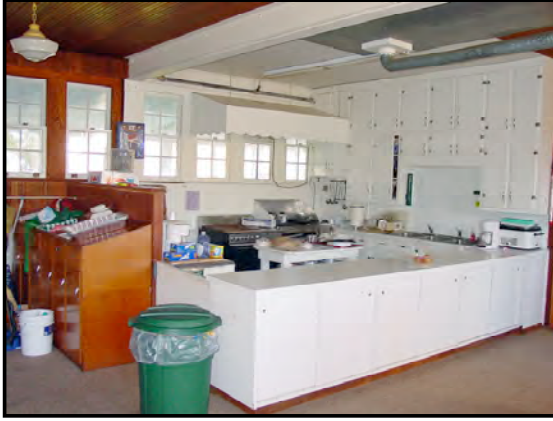
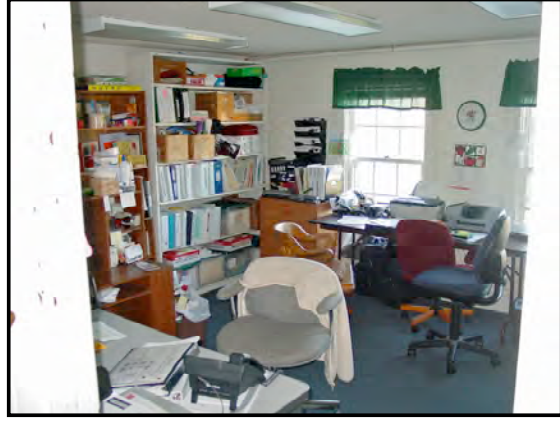
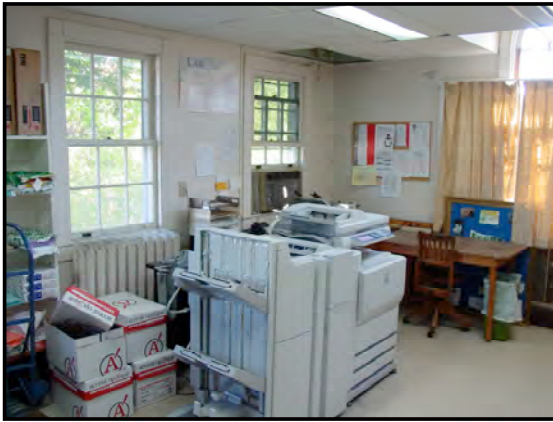
Work Scope 10: Restoration of spaces with some new partitions: Alterations

- Left view: Remove kitchen from assembly space.
- Right view: Renovate offices.
- Lower left view: Relocate copy room.

• Remove obsolete partitioning and trabeate new open span at kitchen =	\$5,000
• Equip new kitchen =	\$20,000
• New partitioning: gypsum board: 100 l.f. @ \$50.00/l.f. =	\$5,000
• New partitioning: folding: 44 l.f. @ \$50/lf. =	\$2,200
• Repair, rehabilitate, restore interior finishes Four times the floor area of a typical room 24 rooms @200 x 4 = 19,200 s.f. @ \$2.50/s.f. =	\$48,000
• Plaster: all ceilings with suspended ceilings removed. Beadboard (assembly space where kitchen in now =	\$5,000
• Replace and/or provide new doors: 12 @ \$1,400/each =	\$16,800
	\$102,000

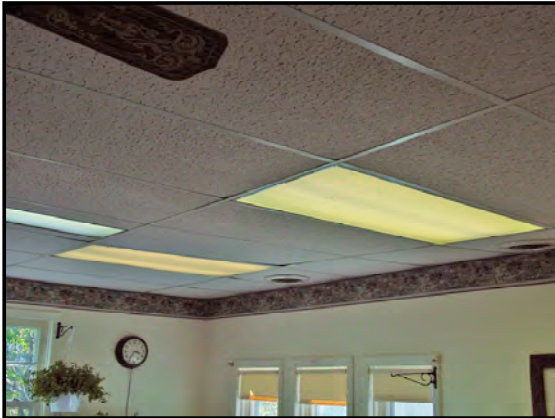
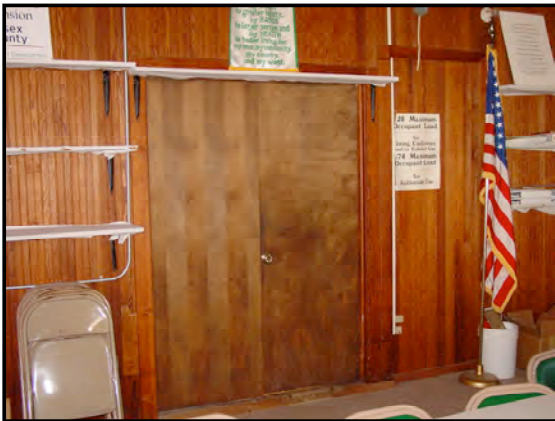
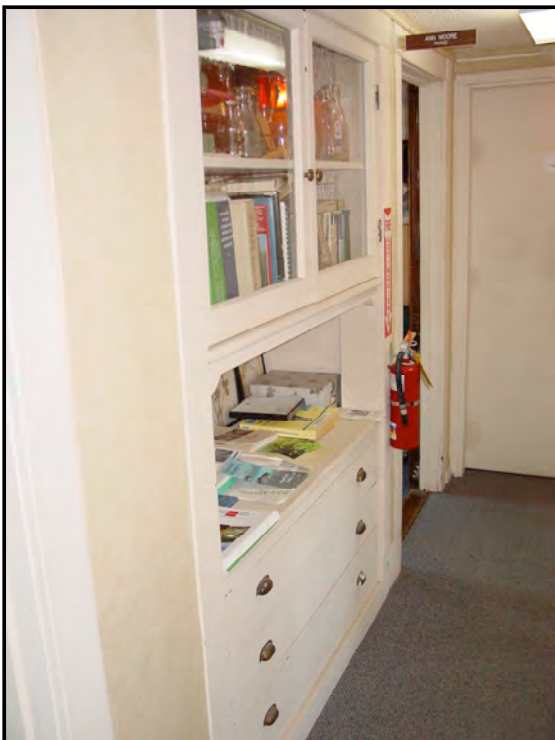
Work Scope 10 Continued: Restoration of spaces: Architectural integrity

- Upper left: Suspended ceiling in reception original area.
- Upper right: Beadboard ceilings above suspended ceiling.
- Center left: Flush doors into assembly space, west partition.
- Center right: Plywood door into assembly space, east partition.
- Lower left: Original built-in cabinet, to be preserved.

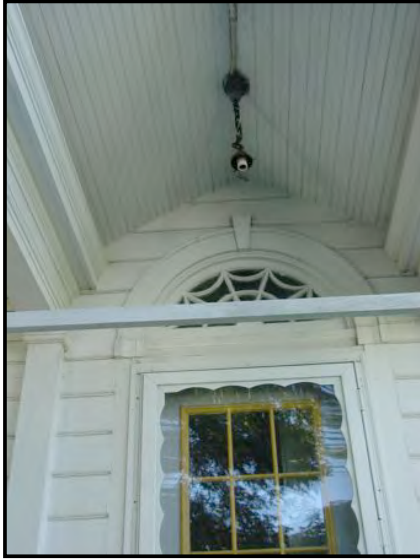
Work Scope 11: Electrical and Fire Alarm

- Upper left: Restore exterior period fixtures
- Upper right: Restore interior period fixtures
- Replace branch circuits

<p>a. Remove all wire mold and surface conduit on the first and second floors and replace with concealed wiring. The removals can occur only when the rooms are vacated for renovation and the new circuitry is dependent upon the new partitioning being in place. 20 rooms @ \$500/room =</p>	<p>\$10,000</p>
<p>b. Remove and replace suspended ceiling fixtures in reception office, in copy room and in County Fair office. 3 @ \$500 =</p>	<p>\$1,500</p>
<p>c. Light fixtures should be replaced and/or restored, depending upon whether they are intrusive, recent/anonymous or historic. The schoolhouse fixtures survive in the main meeting space on the first floor. These have been complemented by strip fluorescents. 24 fixtures @ \$300/each =</p>	<p>\$7,200</p>
<p>The porches and porticoes generally retain their original fixtures, with lamps (incandescent bulbs) and glass shades missing. 6 fixtures @ \$200/each =</p>	<p>\$1,200</p>

<p>d. Outlets and wall switches should be selected in colors and cover plate designs and finishes which complement the 1920s interiors. 20 rooms @ \$200/each =</p>	<p>\$4,000</p>
<p>e. The fire detection heads should be replaced with a centrally monitored system that includes an automatic fire alarm system.</p>	<p>\$12,000</p>
<p>\$35,900</p>

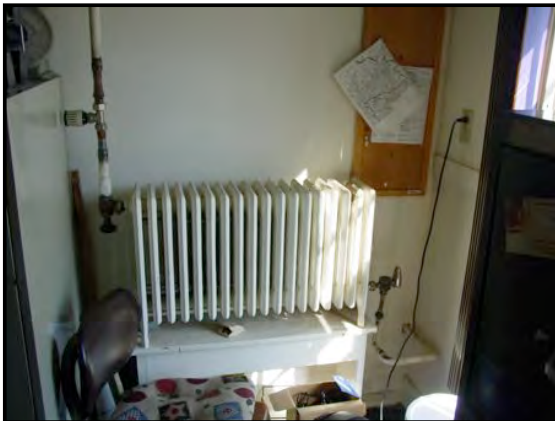
Work Scope 12: Heating System

- Upper views: existing steam radiators
- Middle photographs: existing heating plants, steam boiler, left, and second floor furnace, right.
- Ceiling heater, to be removed and replaced
