PROPOSED WORK SCOPE
WITH
STATEMENT OF POSSIBLE CONSTRUCTION COSTS

FOR REHABILITATION OF THE
AGRICULTURAL CENTER BUILDING
ESSEX COUNTY FAIRGROUNDS
WESTPORT, NEW YORK

PREPARED FOR:
CORNELL COOPERATIVE EXTENSION - ESSEX COUNTY
PO BOX 388, 3 SISCO STREET
WESTPORT, NEW YORK 12993

PREPARED BY:
CRAWFORD & STEARNS
ARCHITECTS AND PRESERVATION PLANNERS
134 WALTON STREET
SYRACUSE, NEW YORK 13202

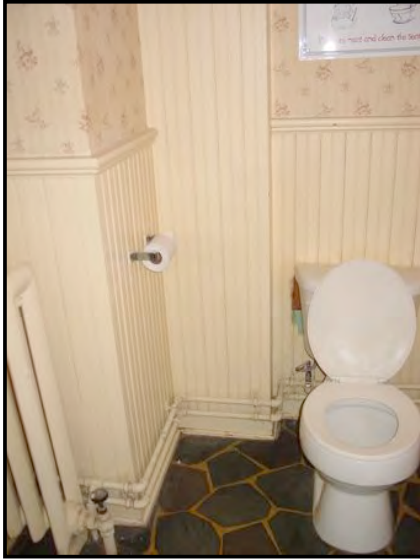
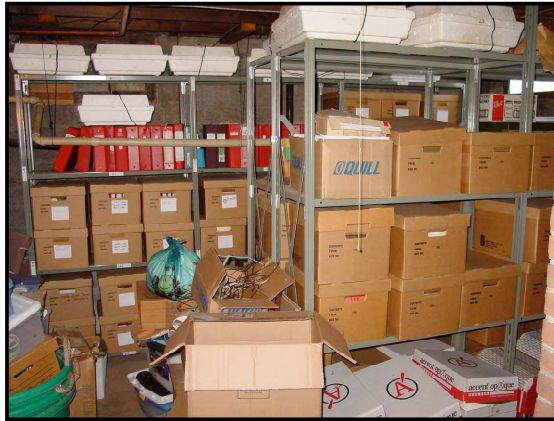
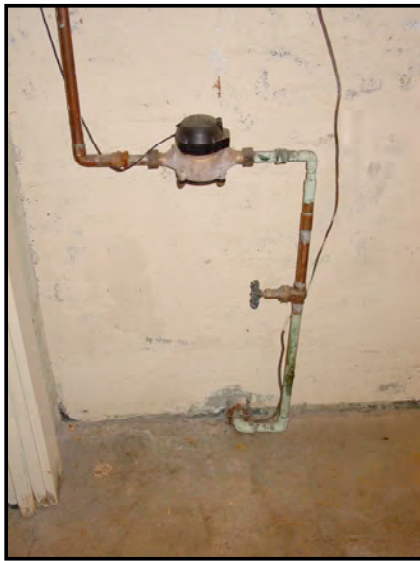
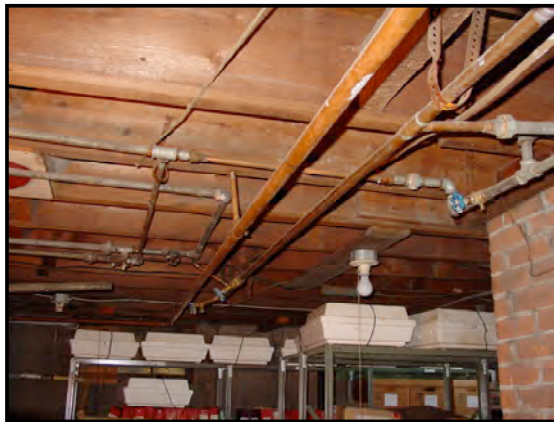
Work Scope 13: Plumbing System

- Upper left: Replace piping with concealed.
- Upper right: Remove waste line (running from current kitchen location) through basement storage (left side, horizontal pipe, above storage boxes).
- Lower left: Replace main supply with $\frac{3}{4}$ " diameter copper.
- Lower right: Replace piping with copper.
