MASTER PLAN

AGRICULTURAL CENTER BUILDING ESSEX COUNTY CCE OFFICES

WESTPORT, NEW YORK

DECEMBER 2005

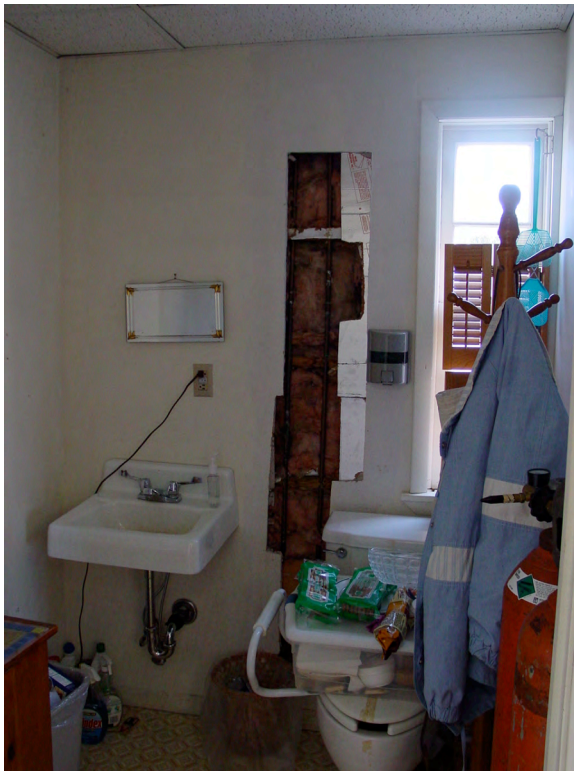
IC-4b: Handicapped accessible toilet room, unused.

Recommendation: Continue to use the existing until renovation adds the new toilet rooms at the east end of the building. At that point, replace piping and connect new facilities with the municipal sewer system.

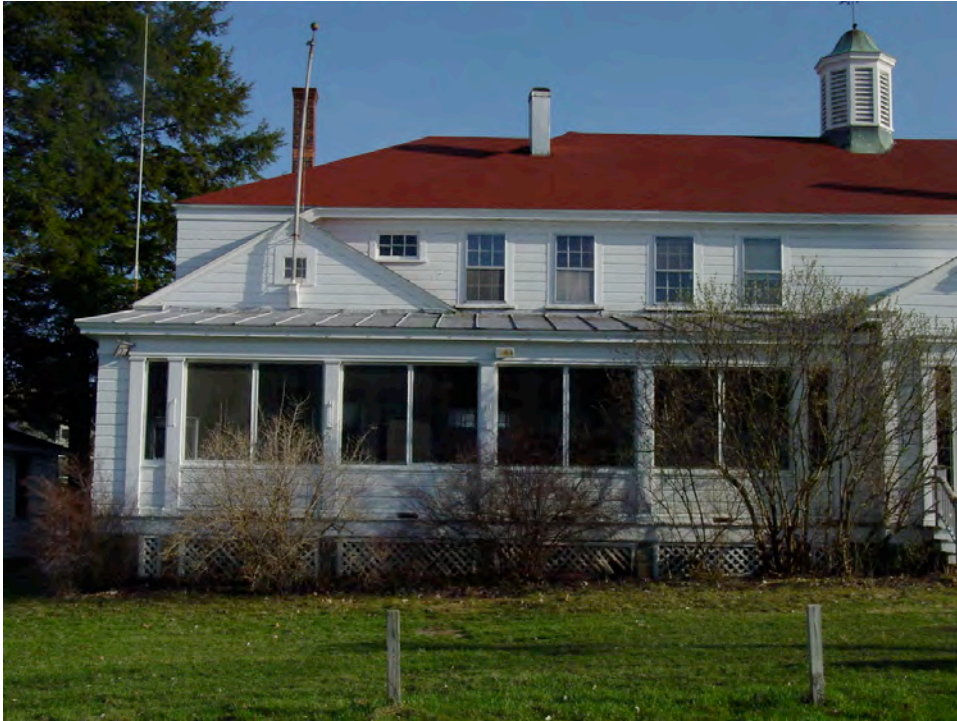
AI-1: The north or back porch, apparently a later addition.

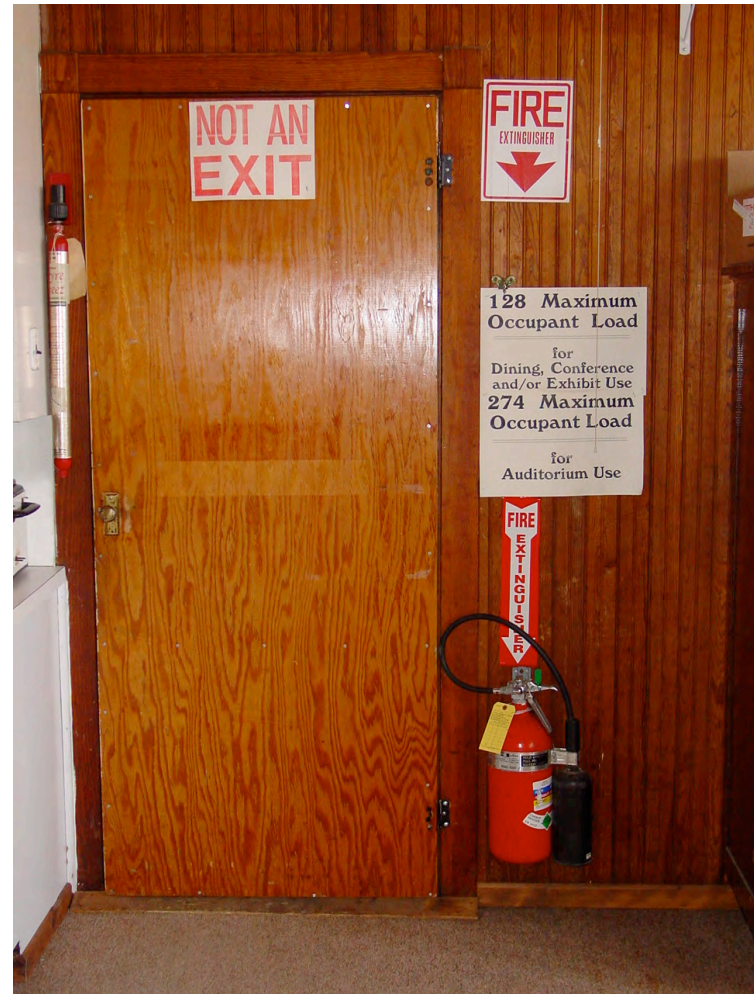
AI-4: Main assembly space with varnished bead board finish and five-panel door covered with plywood.

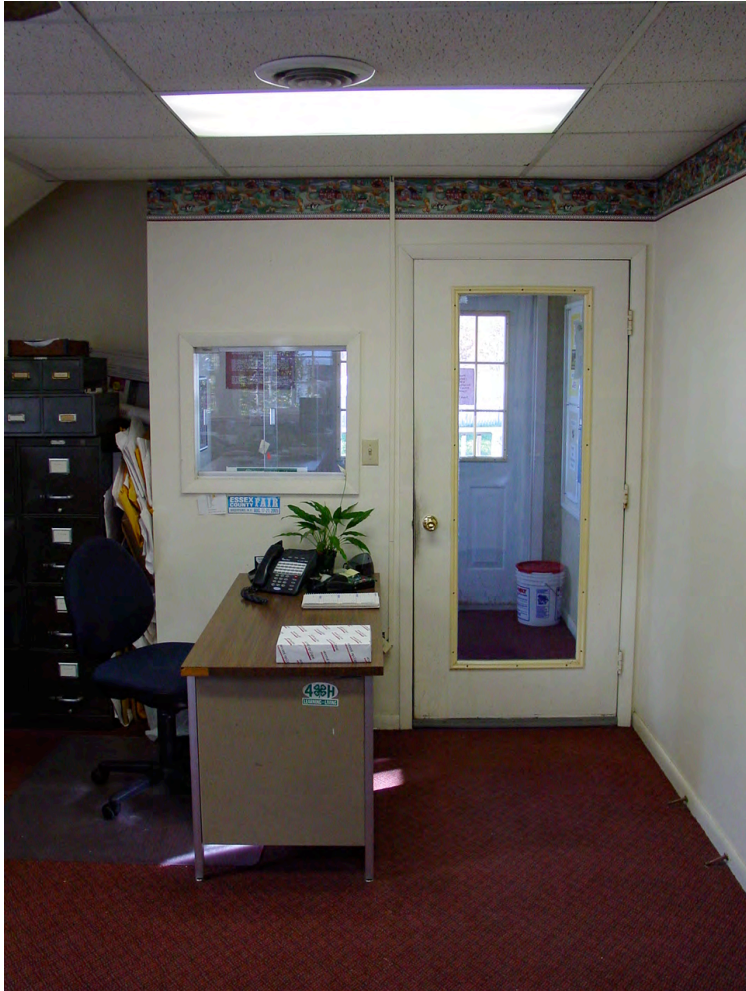
AI-5: Reception area with suspended ceiling, painted gypsum board wall finishes, and stair enclosure to second floor.

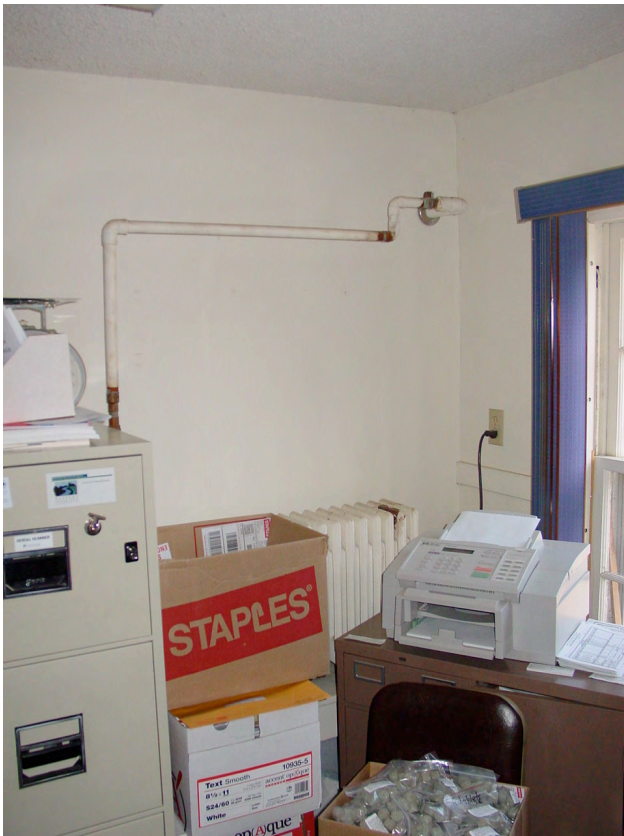
PR-2b: Office on south side of corridor with typical crowding.

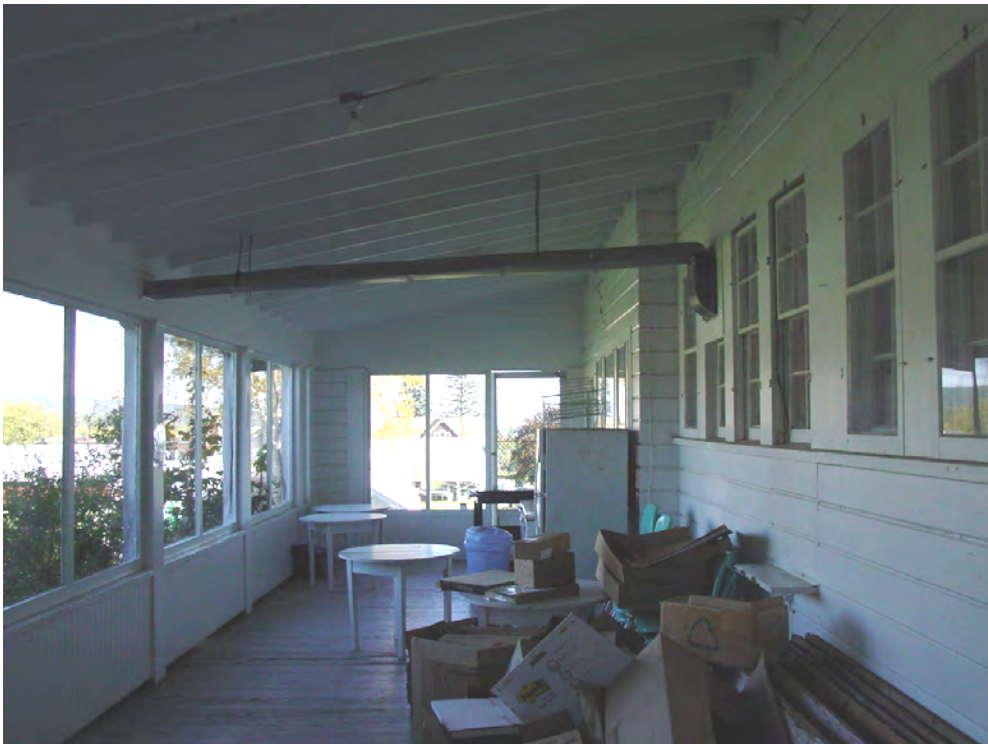
PR-2d: Back (north) porch, used for miscellaneous storage and for County Fair activities.

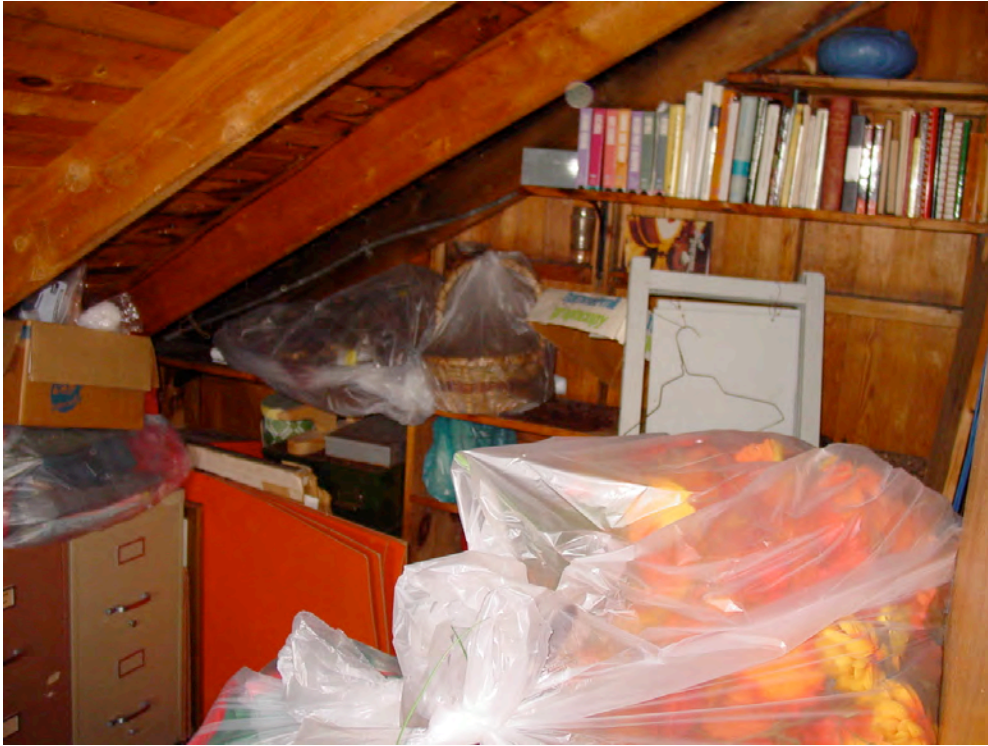
PR-3a: Storage area in southwest attic.

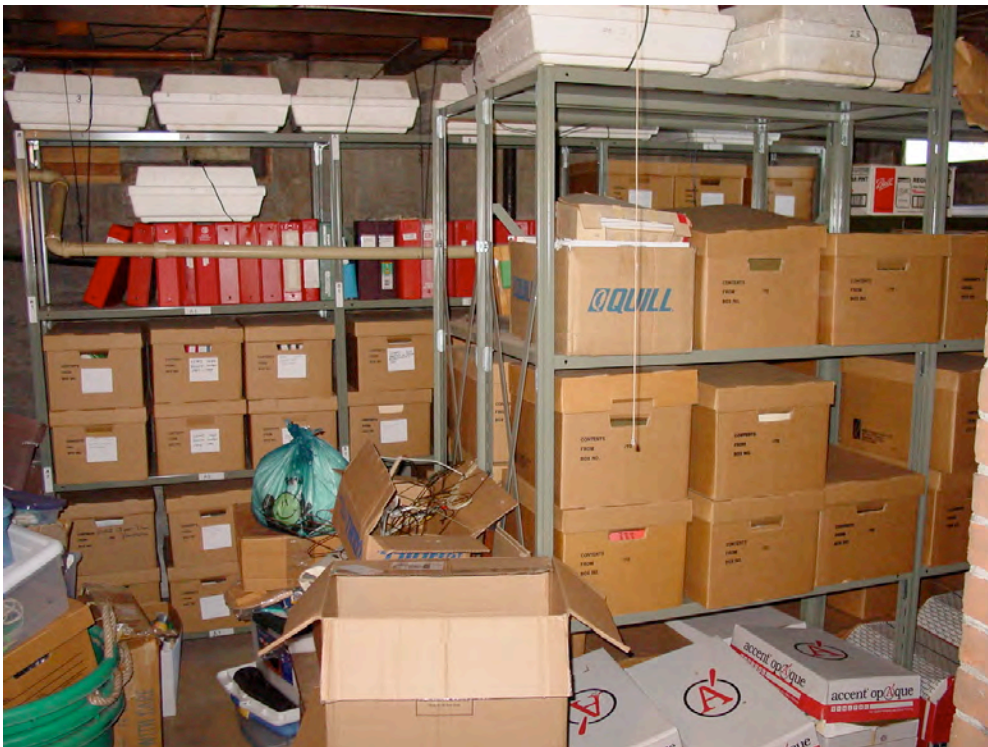
PR-3b: Storage in the basement with the steam boiler.

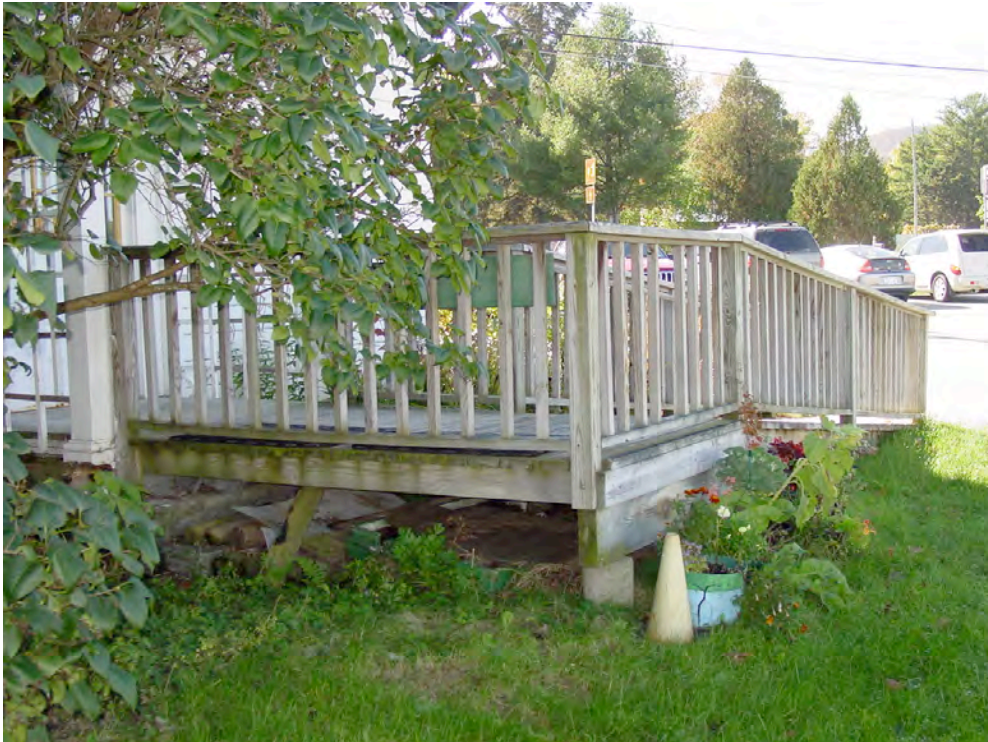
PR-5a: Existing ramp at northwest entrance.
