MASTER PLAN

AGRICULTURAL CENTER BUILDING ESSEX COUNTY CCE OFFICES

WESTPORT, NEW YORK

DECEMBER 2005

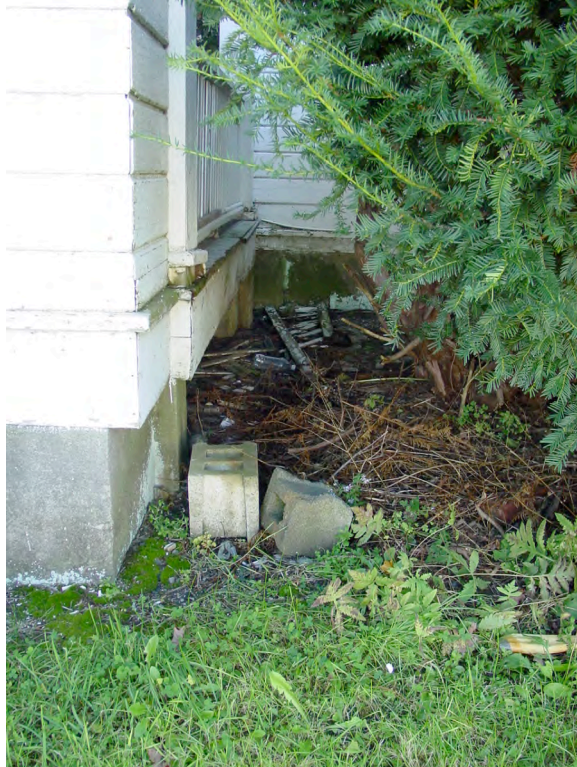
EC-1b: North façade, adjacent to north portico.

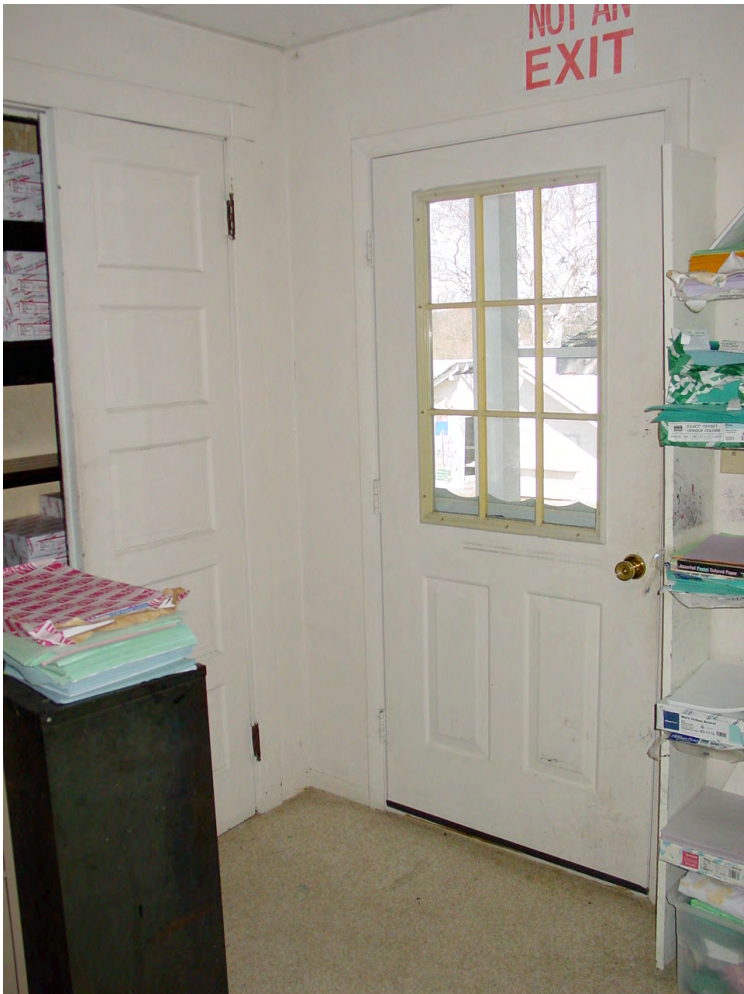
AI-3: Same door, interior view.

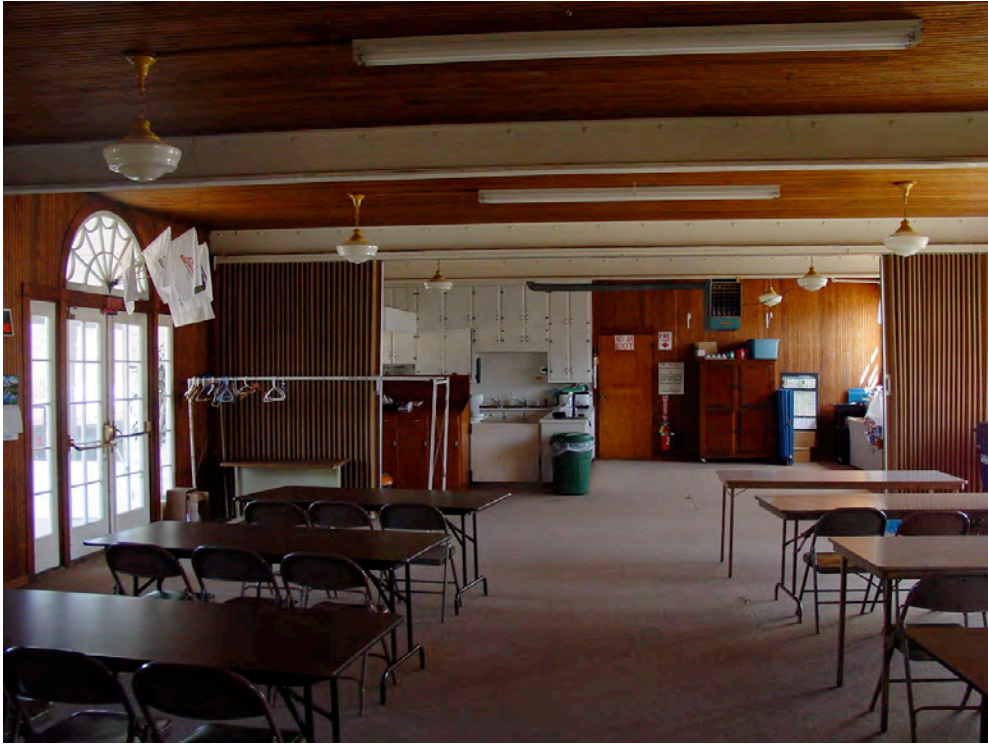
PR-1a: Assembly space.

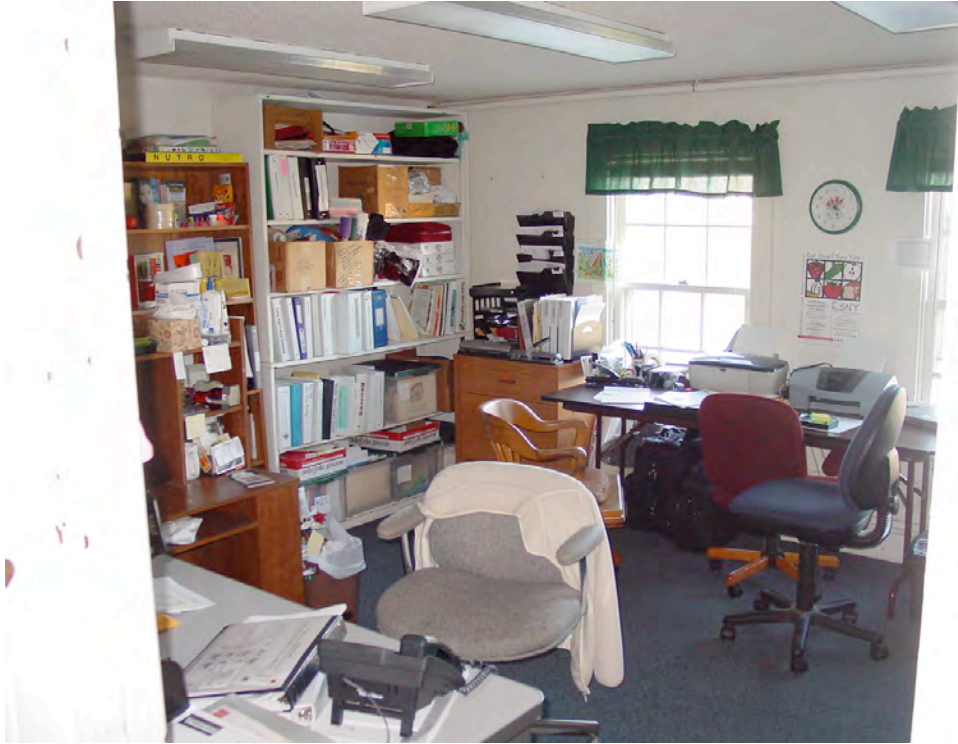
PR-2a: Nutrition Office with chairs for four occupants.

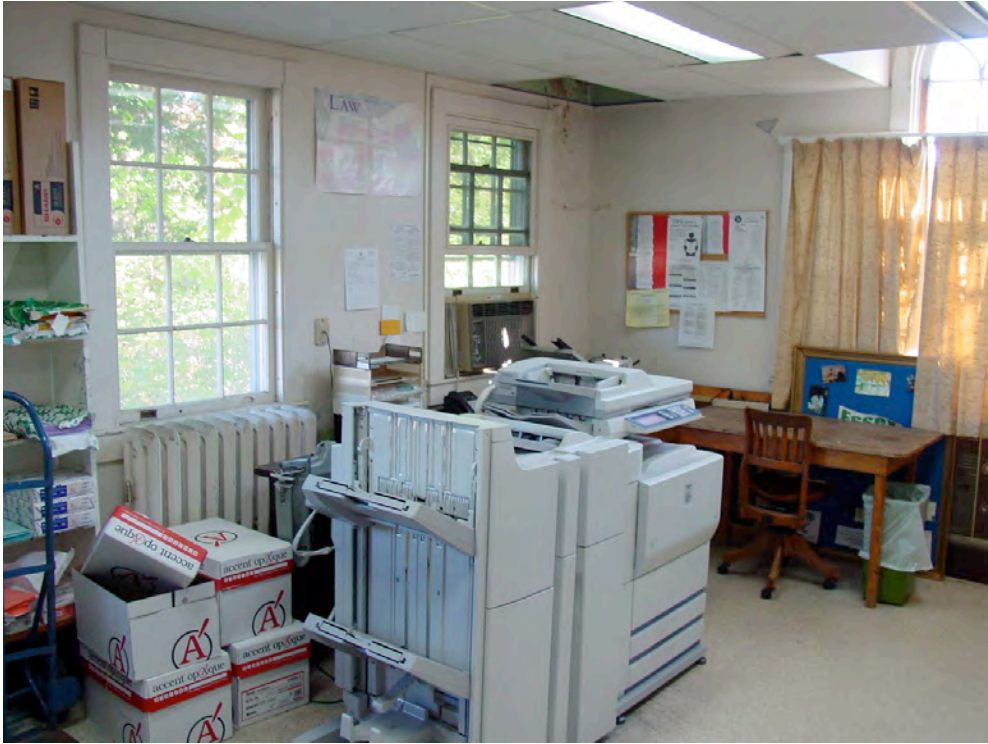
PR-2c: Duplicating room.

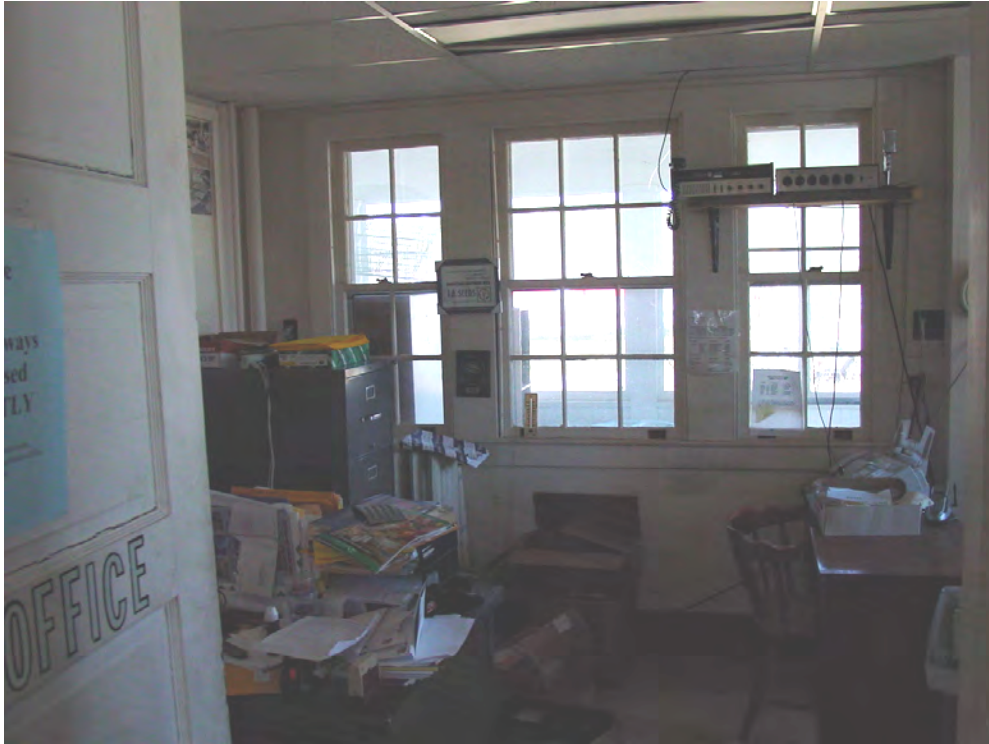
PR-6a: The Fair Office.

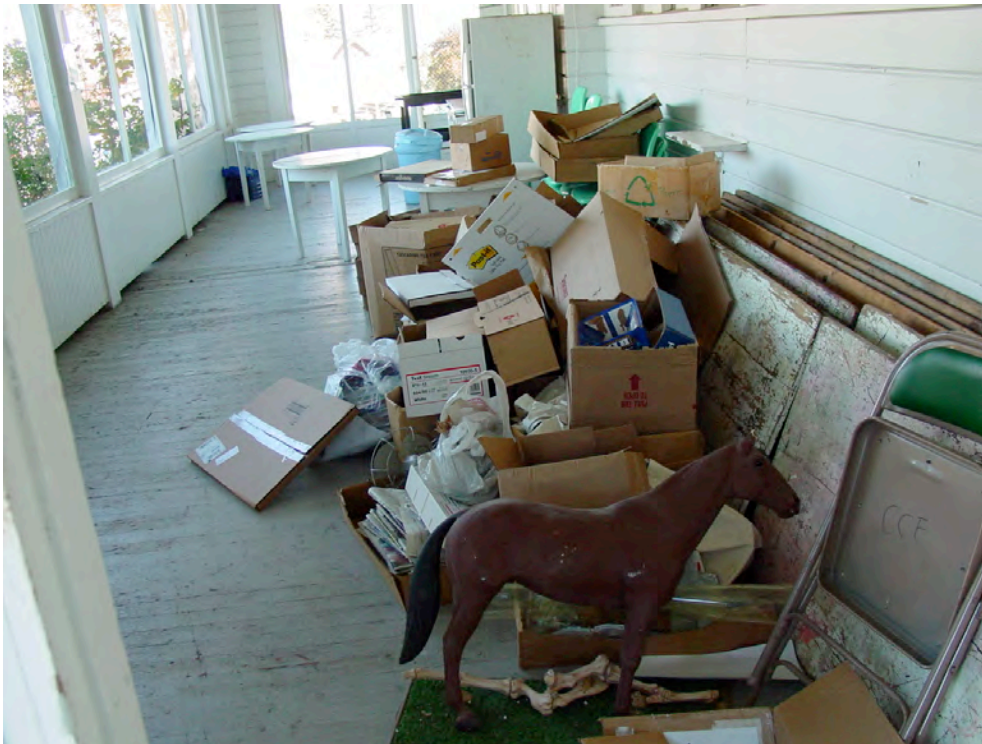
PR-6b: The back (north) porch.
